BEDWELL BAY WRECK — WESTERN DISPATCHER

Official Number: 190573

STATUS

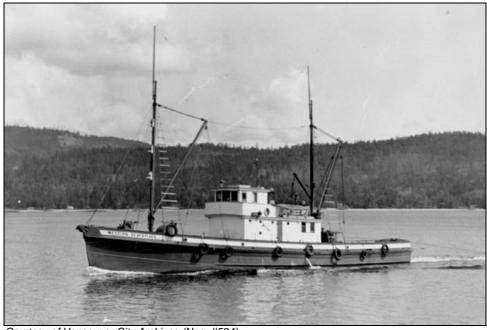
Western Dispatcher as a Fishpacker in 1953

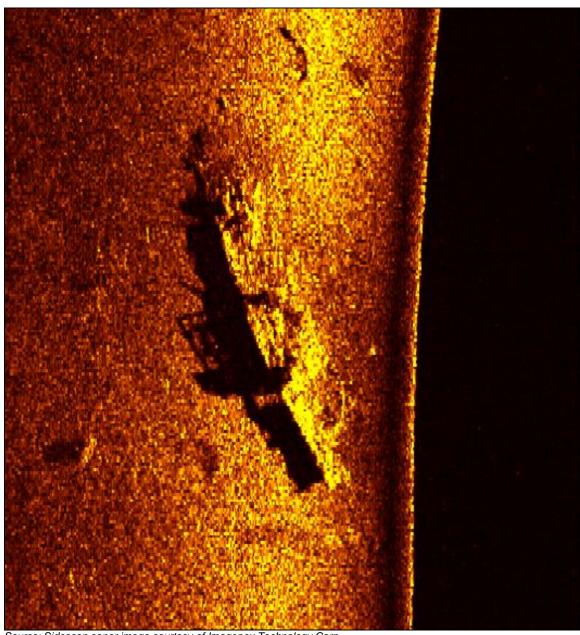
Sidescan sonar image of the shipwreck *Western Dispatcher* in Bedwell Bay (Image from an Imagenex YellowFin 540kHz Sidescan Sonar)
