ROAD CORRIDOR ASSESSMENT REPORT VILLAGE OF BELCARRA

November 1, 2017

4204.0002.01

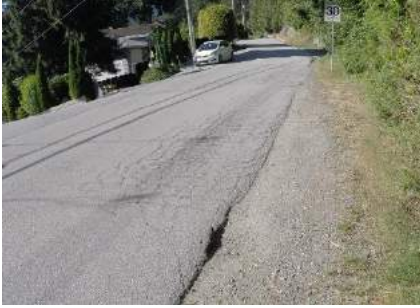
Cracks which follow a course predominantly parallel to the pavement centre line and are located at or near the centre of the wheel path. LWP cracking indicate fatigue failure from heavy vehicle loads. Cracks within one foot of the edge are caused by insufficient shoulder support, poor drainage, or frost action.
Longitudinal Joint Cracking (LJ)

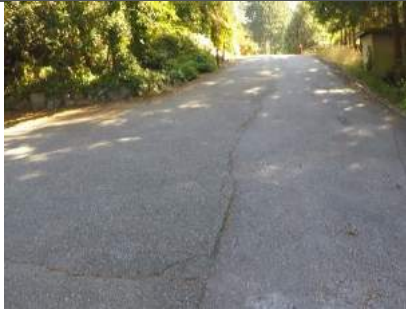
Cracks running in the direction of traffic are longitudinal cracks. Centre line or lane cracks are caused by poor construction of longitudinal joint, frost action on adjacent lanes with variable granular depths.
Pavement Edge Cracking (PEC)

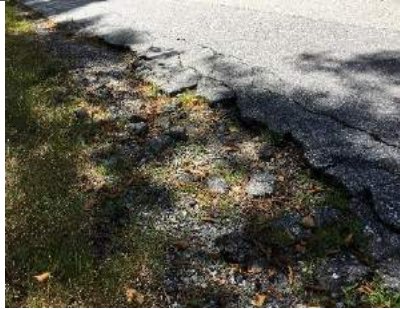
Cracks which occur parallel to and within 0.6 metres of the inside and/or outside of the fog line. Cracks may be crescent shaped cracks or other fairly consistent cracks which intersect the pavement edge. Possible causes include: Frost action, inadequate pavement structural support at the pavement edge and/or excessive traffic loading, poor drainage at the pavement edge and shoulder, inadequate pavement width forces traffic too close to the pavement edge.

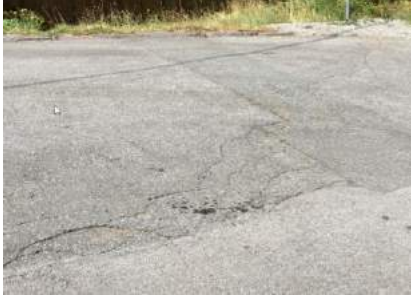
<p>Cracks that are predominantly perpendicular to the pavement centre line and extend fully or partially across the roadway.</p> <p>Possible causes include: surface shrinkage caused by low temperatures, temperature susceptibility of the asphalt cement binder in asphalt mixes, frost action, reflection cracks and hardening of the asphalt with aging</p>
Meandering Longitudinal Cracking (MLJ)

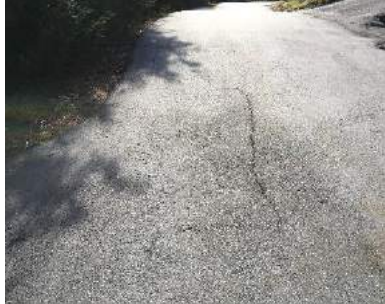
<p>Cracks which wander from edge to edge of the pavement or run parallel to the centre line, situated near the middle of the lane. MLJ cracks are usually single cracks, but secondary cracks can develop in areas where transverse thermal cracks also exist.</p> <p>Possible causes include: Frost action with greater heave at the pavement centre than at the edges. This is more prevalent in mixes where asphalt stripping is extensive. Faulty construction equipment can cause weak planes in the mix, which can fail from thermal shrinkage</p>

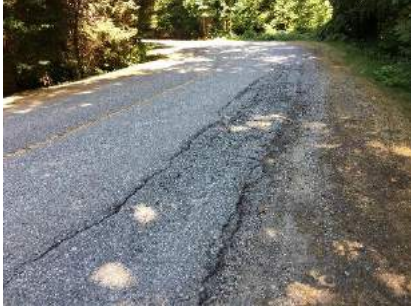
<p>Cracks which form a network of multi-sided blocks resembling the skin of an alligator. Block size can range in size which indicates the depth of failure taking place. The pattern of cracking is usually longitudinal, originating in the wheel paths, but can occur transversely due to frost heaves or settlement and also along the centre line on narrow two-lane roads.</p>

DISTRESS	IMAGE	CAUSE
		<p>Possible causes include: areas subjected to repeated traffic loadings. Insufficient bearing support due to poor quality base materials or saturated base with poor drainage, stiff or brittle asphalt mixes at cold temperatures.</p>
Rutting (RUT)

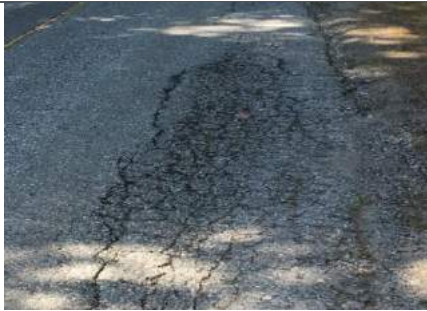
<p>Longitudinal depressions left in the wheel paths after repeated loadings, combined with sideways shoving of the pavement material.</p> <p>Possible causes include: Poorly compacted structural layers, Heavy loadings of saturated unstable granular bases/sub-bases during spring thaw periods, unstable asphalt mixes due to high temperature or low binder viscosity, inadequate lateral support from unstable shoulder materials, permanent deformation of an overstressed subgrade</p>
Shoving (SHV)	<div data-bbox="446 1255 841 1314">None observed in Belcarra</div>	<p>Longitudinal displacement of a localized area of the pavement surface generally caused by braking or accelerating vehicles and usually located on hills, curves or intersections.</p> <p>Possible causes include: Heavy traffic on steep downgrades or upgrades, low stability asphalt mix, lack of bond in asphalt surface and underlying layer, unstable granular base.</p>

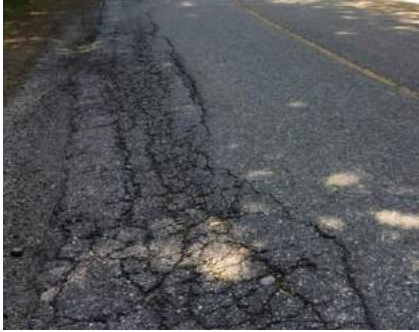
<p>Any deviation of the pavement surface from its original shape other than that described for shoving and rutting. Generally, distortions result from settlement, slope failure, volume changes due to moisture changes and to frost heaving, and from residual effects of frost heaving accumulating after each season.</p> <p>Possible causes include: Differential frost heaves in poorly drained cuts, transitions and at pavement edges or centre. reverse differential frost heave at culverts, differential settlement of subgrade or base materials, lack of subgrade support, embankment slope failure.</p>
Bleeding (BLD)	<div data-bbox="441 1058 836 1121">None observed in Belcarra</div>	<p>Excess bituminous binder on the pavement surface can create a shiny, glass-like, reflective surface that may be tacky to the touch. Bleeding quite often occurs in the wheel paths.</p> <p>Possible causes include: Mix design deficiencies where too high an asphalt content relative to voids results in excess asphalt forced to the surface by traffic, especially on hot days, paving over surfaces with severe bleeding or the application of a heavy prime or tack coat under a new pavement layer may result in excess primer bleeding through the pavement surface over a period of time, poor construction of surface seal coats.</p>

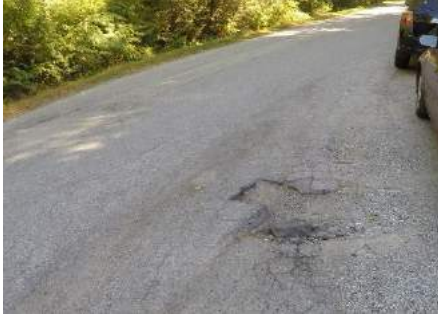
<p>Bowl-shaped holes of various sizes in the pavement surface.</p> <p>Possible causes include: Thin spot in the asphalt layer, localized drainage problems such as water infiltration through poorly bonded pavement structural layers or segregated spots in the asphalt mix where coarse patches allow intrusion of water, asphalt mix design deficiencies.</p>
Ravelling (RAV)

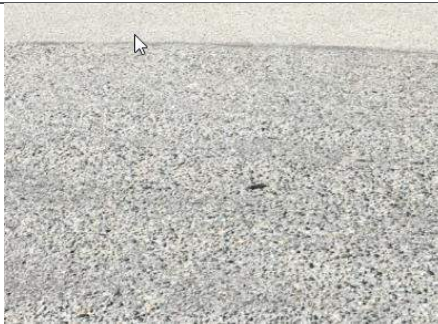
<p>The progressive loss of the pavement material from the surface downward, leaving a rough surface, vulnerable to weather deterioration.</p> <p>Possible causes include: poor adhesion of aggregates due to insufficient asphalt content, clay-coated aggregate, use of wet aggregates or stripping due to water action, fracture of aggregate particles by heavy loads or natural causes, the unbound particles are then removed by traffic, reducing the depth of the asphalt, poor compaction permits infiltration of water and salts which promote asphalt stripping, segregated mix placed during construction, aging and weathering.</p>

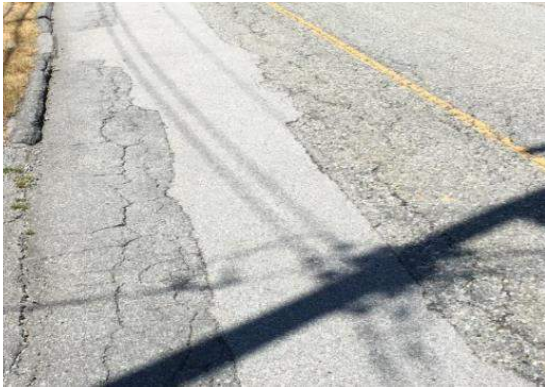
Figure 4: Examples of the Condition of Patching and Crack Sealing

Level 2 Patch - In poor condition

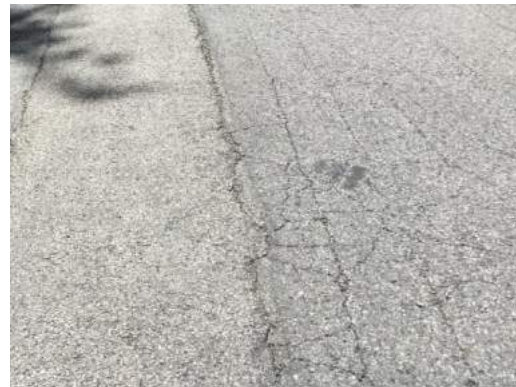
Inadequate crack sealing

We recommend an increased focus on crack sealing and patching until the Village has addressed most of the high and moderate severity cracking. Crack sealing should include the trench joint edges along the new and old asphalt from the recent water system installation.

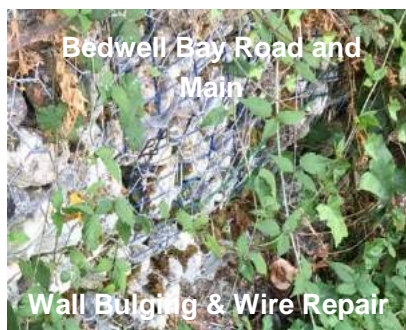
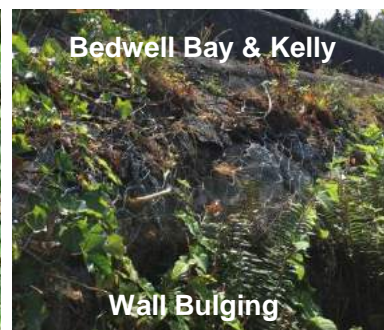
The only notable deficiencies found are on the two gabion retaining walls. The walls are at the intersection of Bedwell Bay Road and Main Avenue and the other retaining wall is at Bedwell Bay Road and Kelly Road. Both walls show signs of wire deterioration and bulging. Village staff have been maintaining the wall at Bedwell Bay Road and Main Avenue by adding wire and reseating the fill rock to keep it in place. The north-west lane of Bedwell Bay Road is built on top of the gabion wall at Bedwell Bay Road and Kelly Road and therefore this wall would have the highest impact if the wall was to further deteriorate or fail. It is our recommendation that both walls be assessed by a qualified Geotechnical Engineer to determine if there are any concern with these walls, provide recommended actions, timing and cost if any work should be considered in the next 5-10 years.

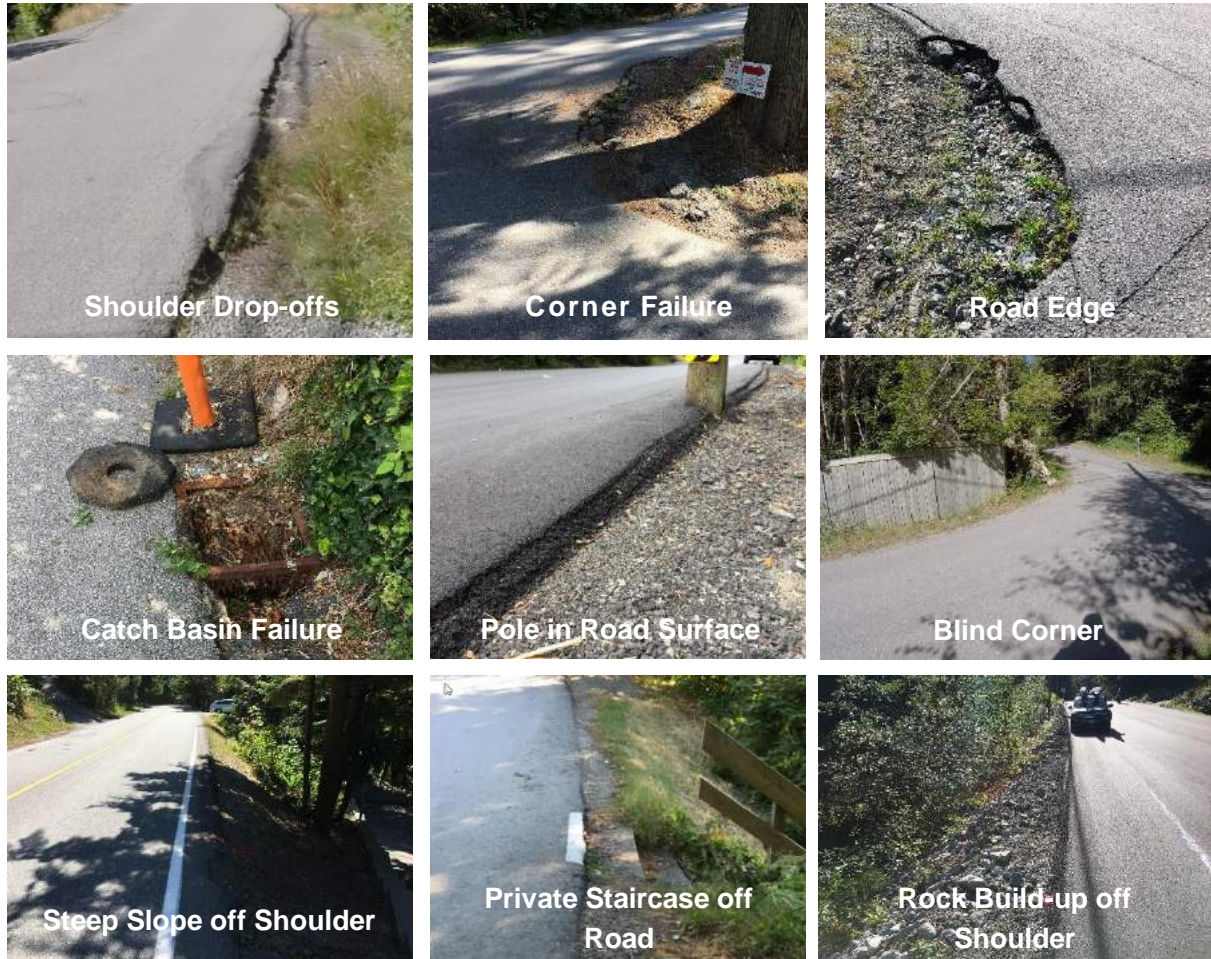
Figure 9: Safety Concerns Found During the RCA

- Potholes, road edge, corner failures and shoulder drop-offs;
- Catch basin failure;
- Steep slopes with no roadside barriers;

- A power pole within paved road surface;
- Blind corner;
- Private stair case that starts at road edge; and
- Cross-walk signage.

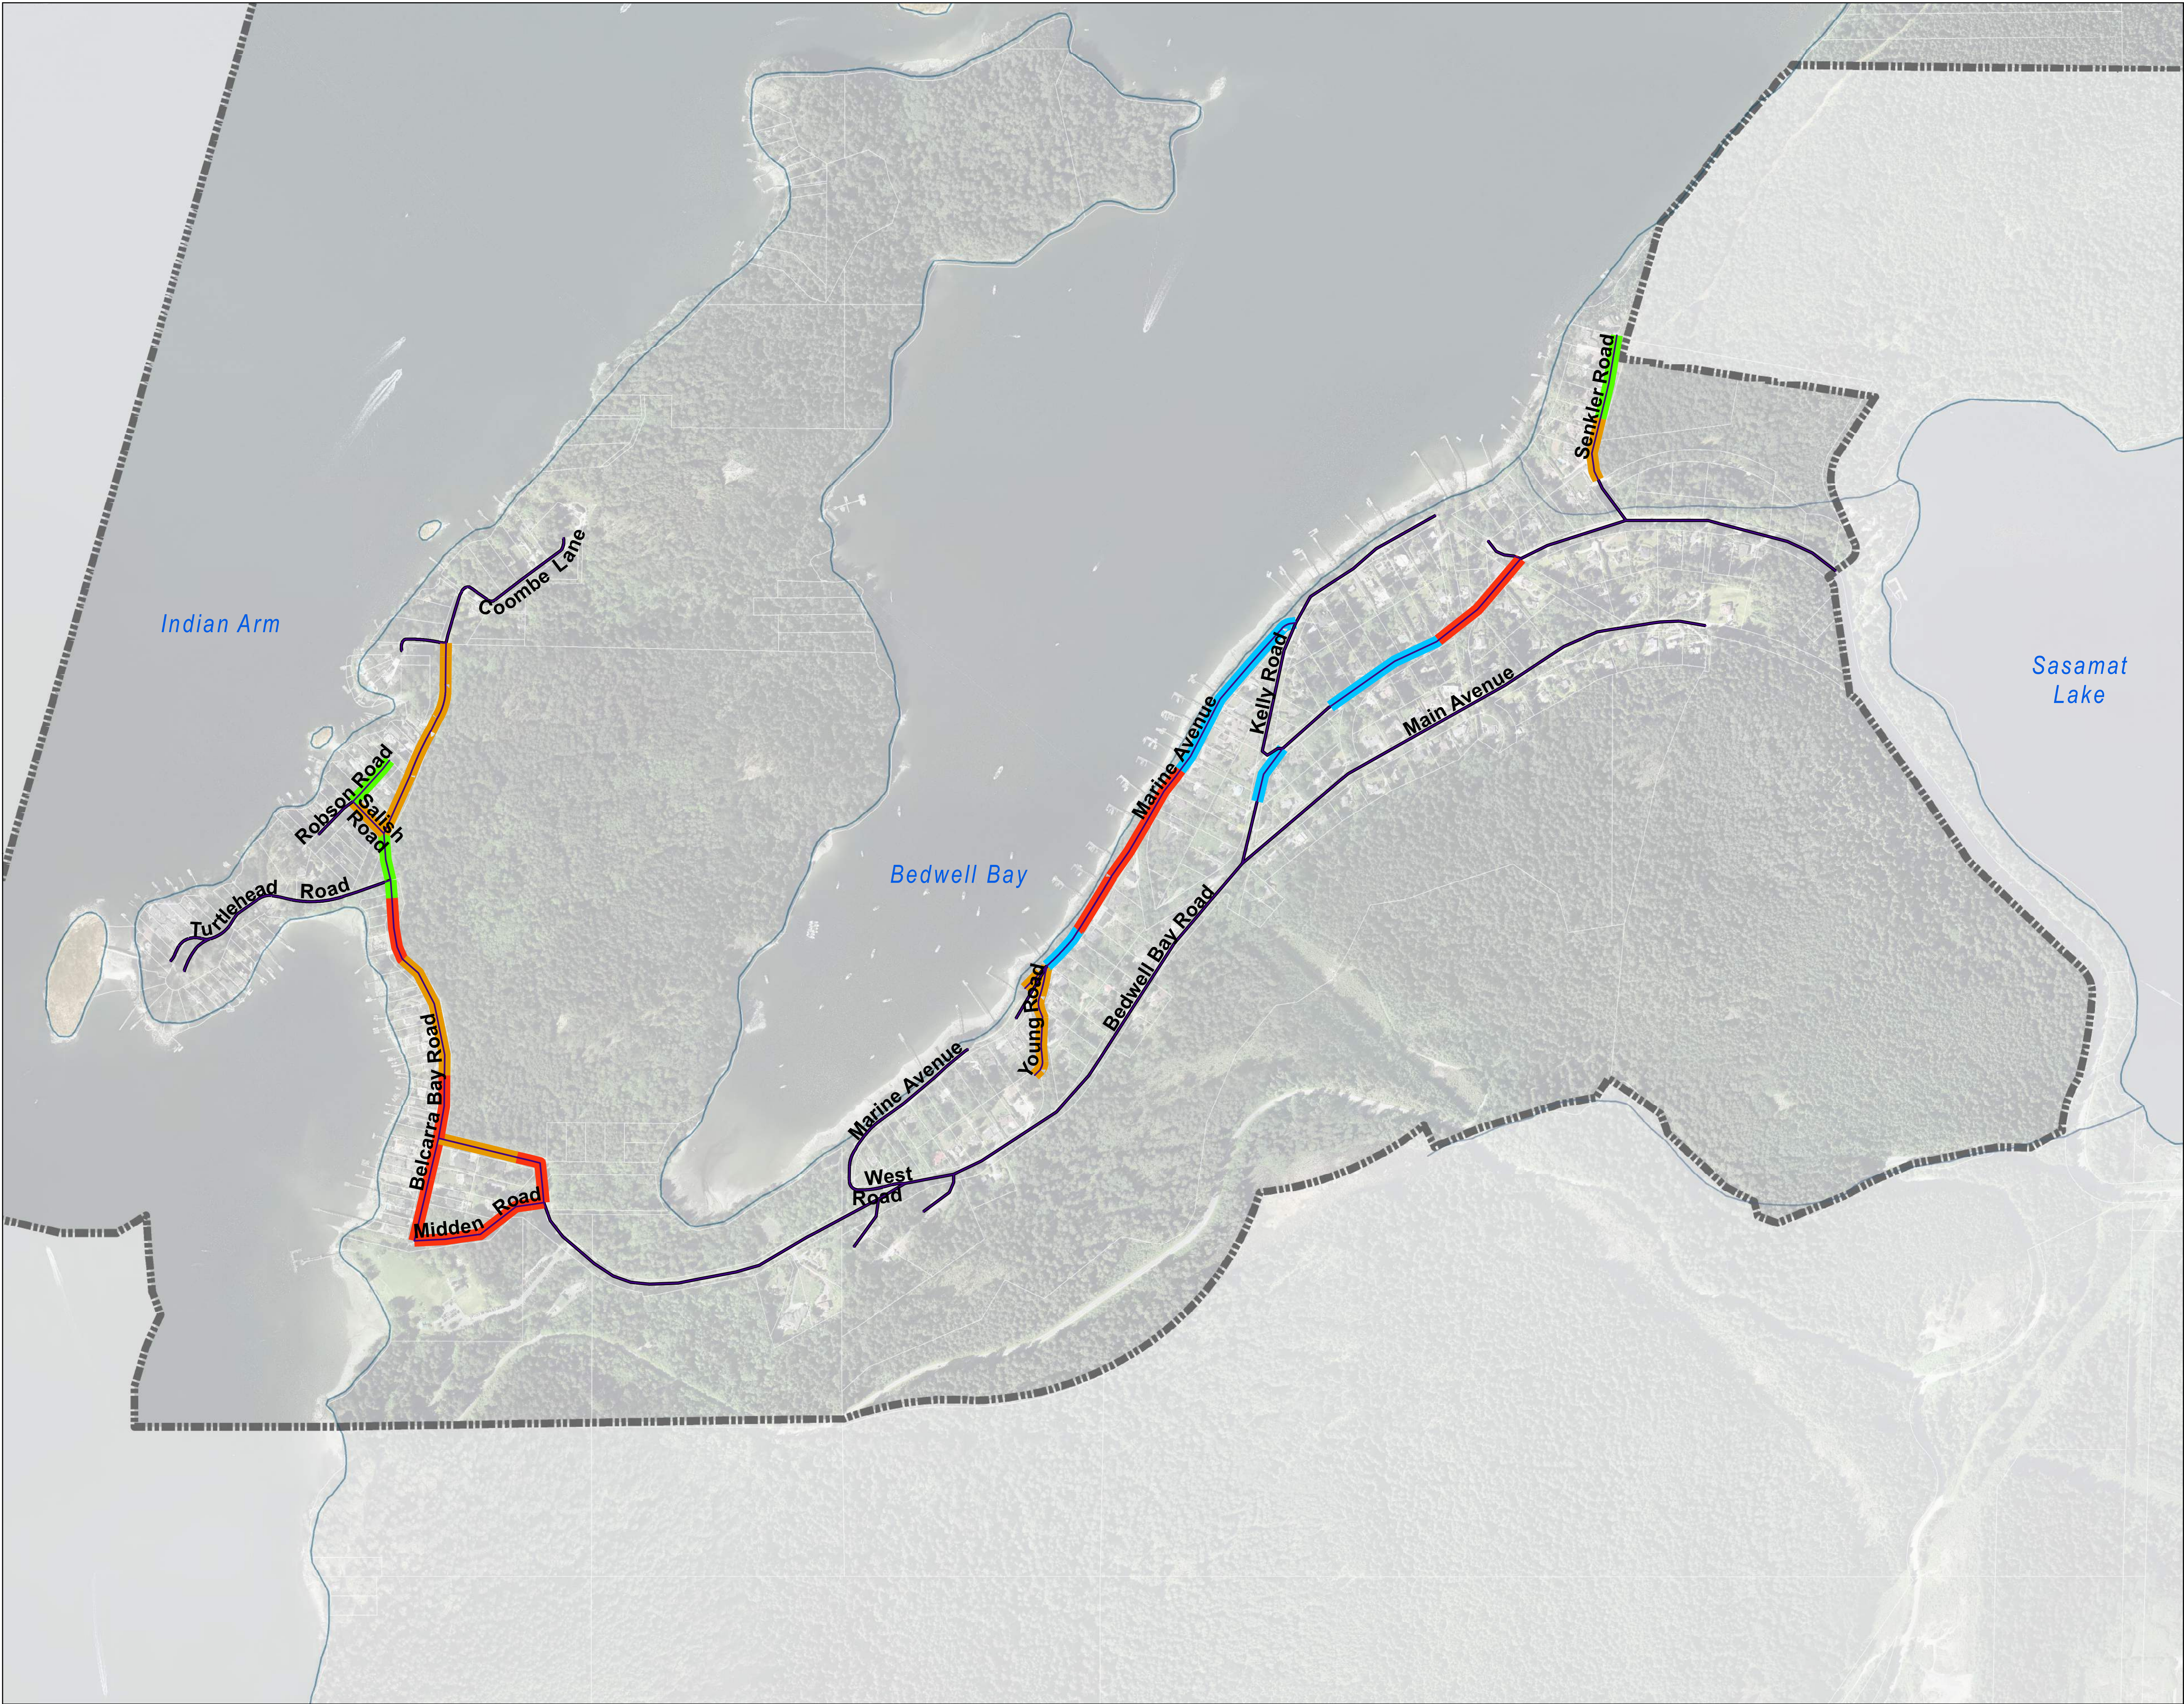
During the RCA, roads that appeared to show signs of base failure were flagged for further review. Map 4 – Road Surface with Distresses Indicating Potential Base Failure in Appendix A shows the result of the RCA and the roads with distresses indicating potential base failure. The distresses noted include:

- Moderate to severe longitudinal wheel path cracking;
- Moderate to severe pavement edge cracking with distortion;
- Roads with moderate to high severity rutting and distortion; and
- Alligator cracking.

We recommend the Village undertake the following to better understand the existence and condition of the road base prior to undertaking significant roadwork projects:
