Road Assessment Project Presentation to Council

The Village of Belcarra

September 18, 2017

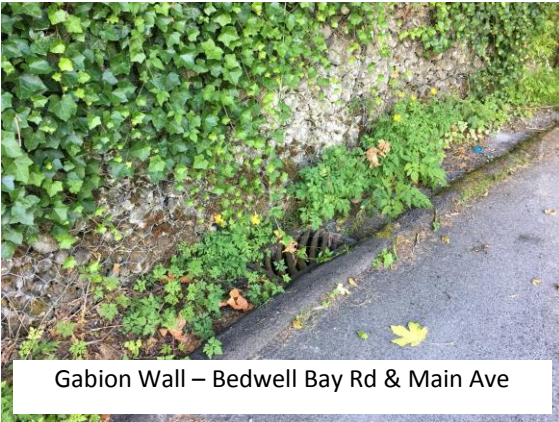
Gabion Wall – Bedwell Bay Rd & Main Ave

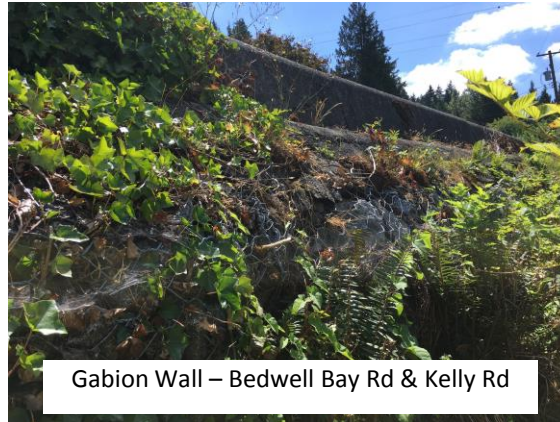
Gabion Wall – Bedwell Bay Rd & Kelly Rd

- Gabion Wire Deterioration
- Bulging and Undercuts

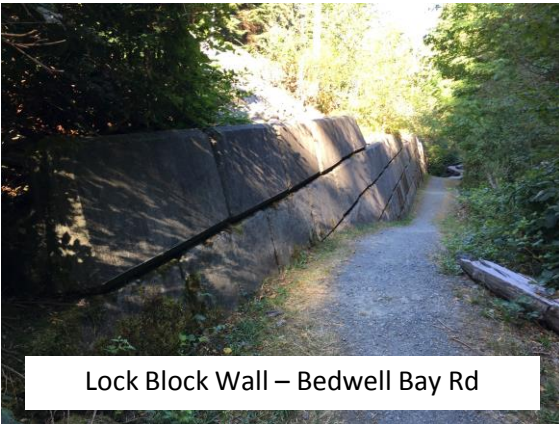
Lock Block Wall – Bedwell Bay Rd

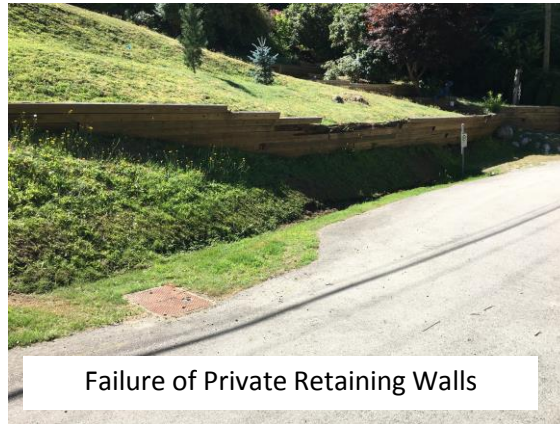
Failure of Private Retaining Walls

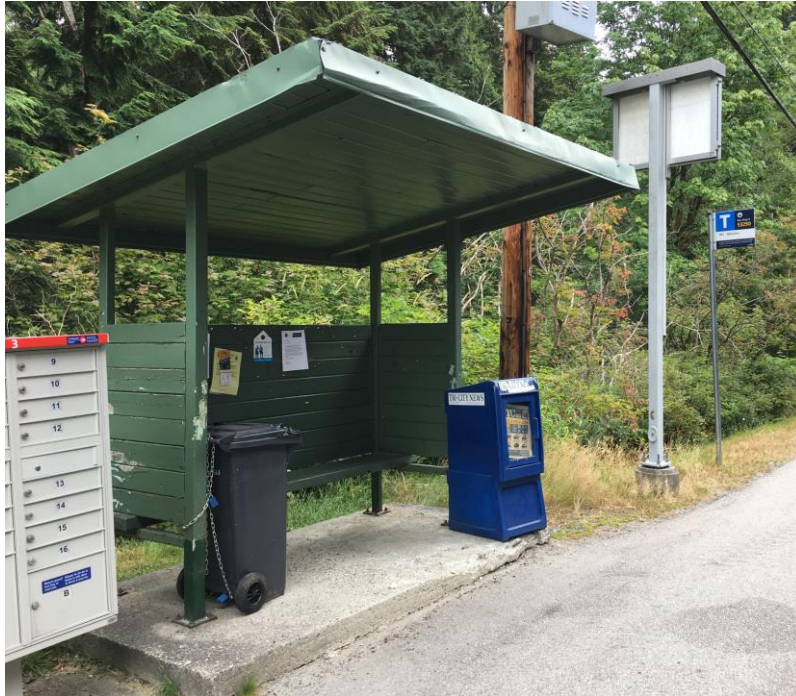
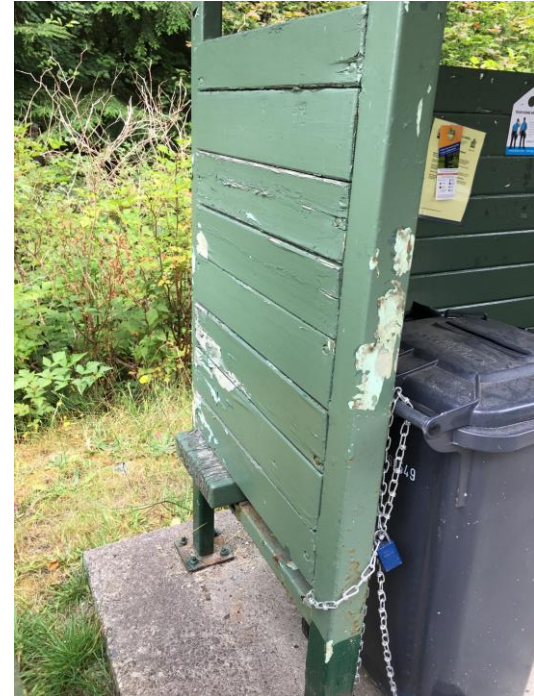
Deficiencies Observed

- Paint peeling
- Minor rotting of wall and roof boards

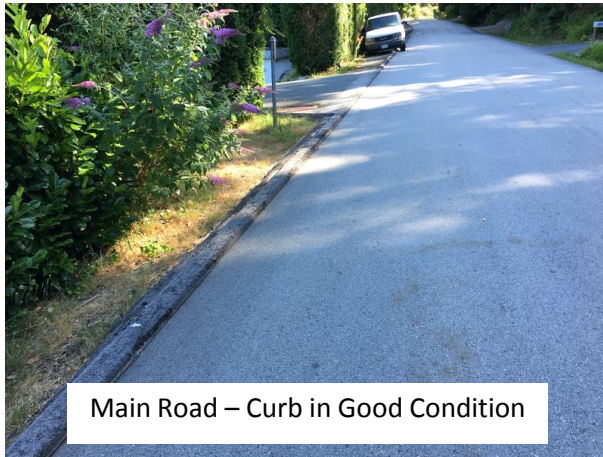
Main Road – Curb in Good Condition

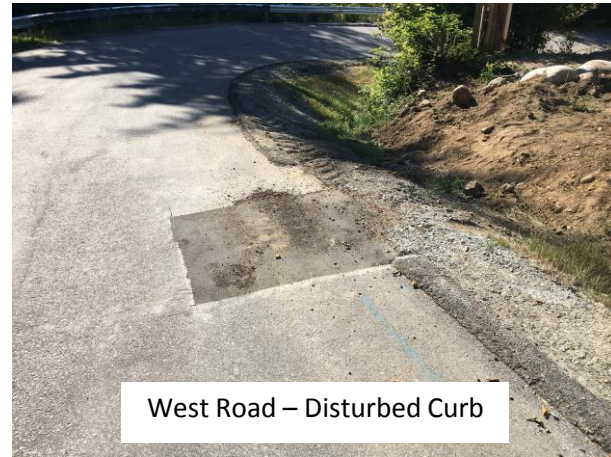
West Road – Disturbed Curb

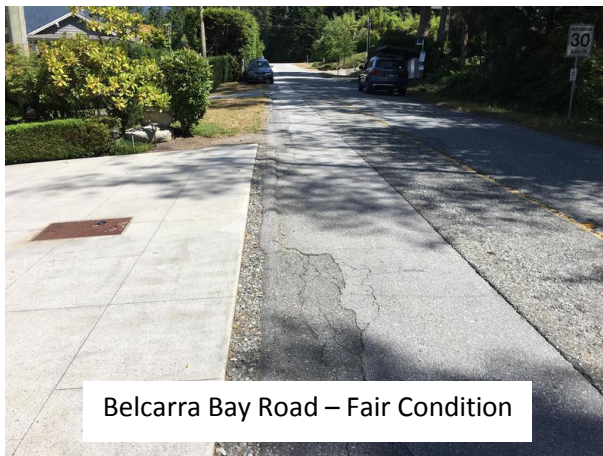
Belcarra Bay Road – Fair Condition

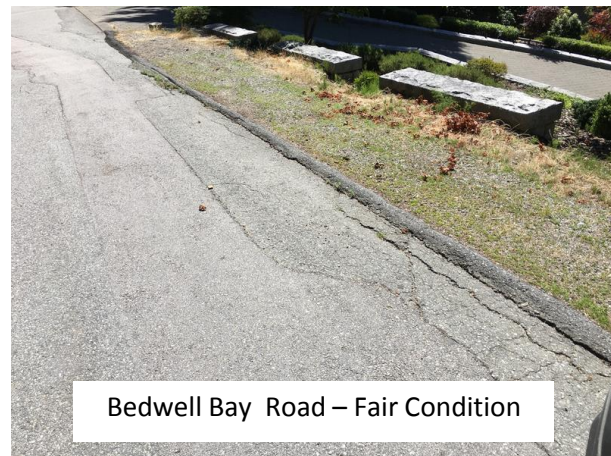
Bedwell Bay Road – Fair Condition

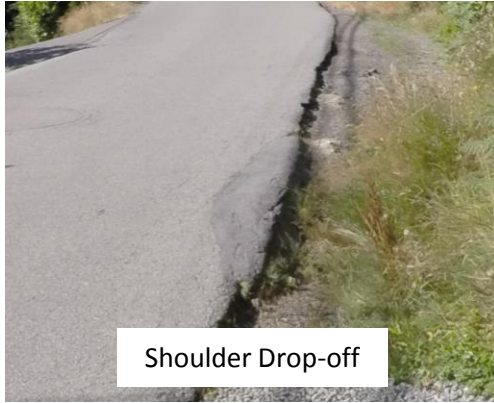
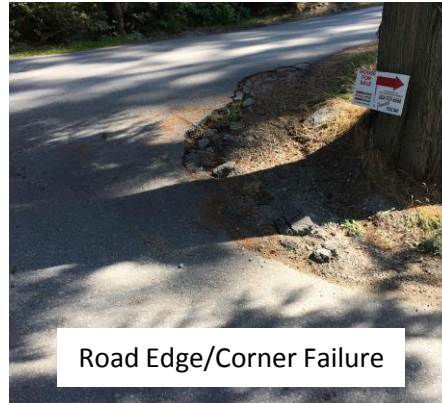
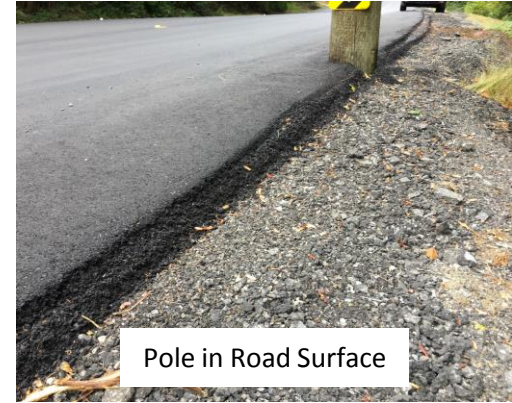
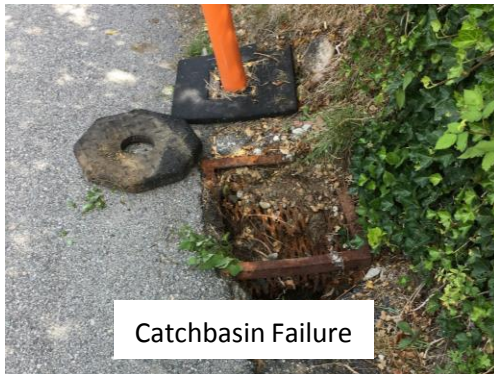
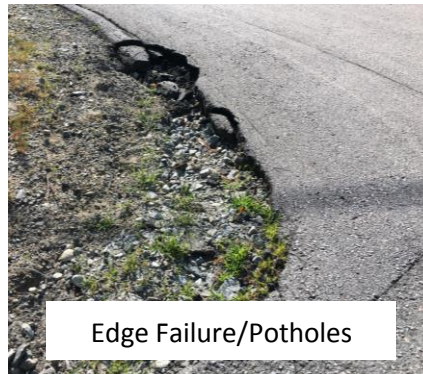
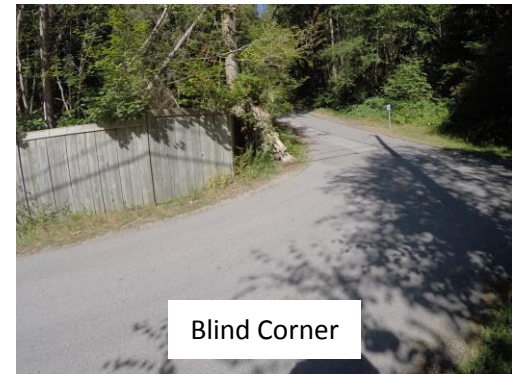
Vehicle and Cycling Hazards

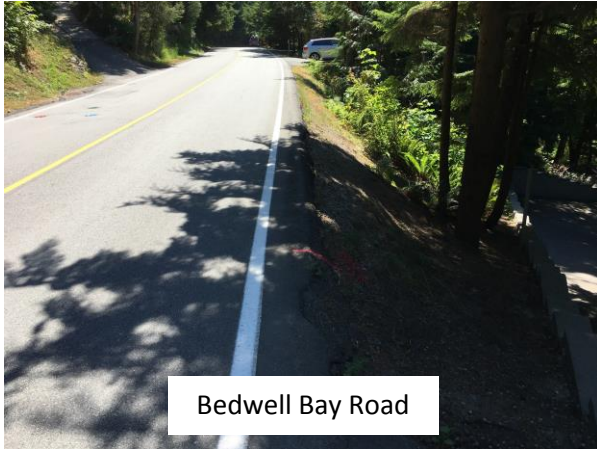
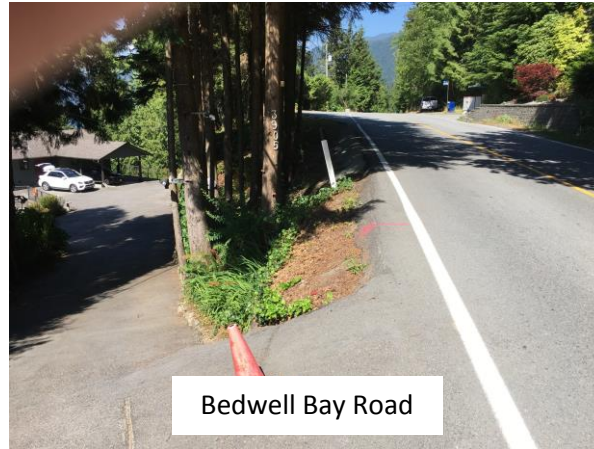
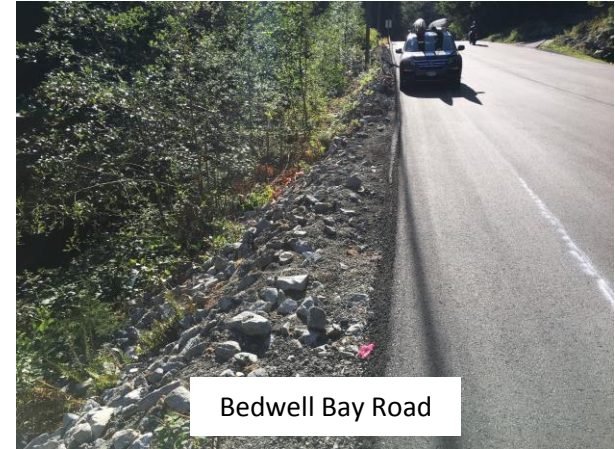
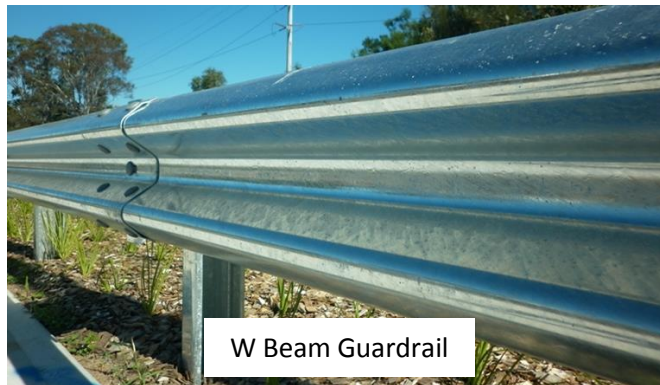
Vehicle, Cycling and Pedestrian Hazards

Addition of Guardrails
along steep slopes
+/- \$80 per meter
