Subject: **Windermere Creek – Hydrotechnical Assessment, Drainage Study**

Technical Memorandum

RE: **WINDERMERE CREEK**
Hydrotechnical Assessment of Windermere Creek
Our File 2272.003-300

This report provides documentation of the 2017 flood and erosion overview assessment of Windermere Creek and a limited assessment of the downstream reach of Avalon Creek in the Village of Belcarra.

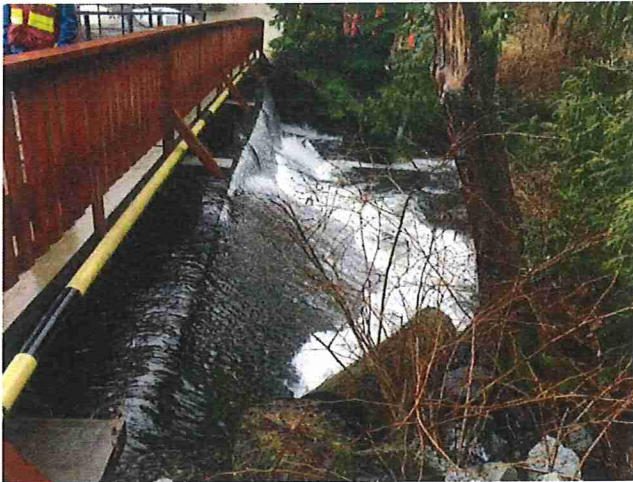
- Depth of flow over weir on March 3 was 11-11.5 cm (33.5 cm below the existing top of concrete which chain link fence sits on). The weir narrows from approximately 19 m to 10-12 m.
- On June 29, the weir had no flow over it, with the only flow from the low-level pipe.
- Windermere Creek is wide and meandering near the Sasamat Lake outlet with a gentle slope.

Photo 1: Sasamat Lake outlet March 3

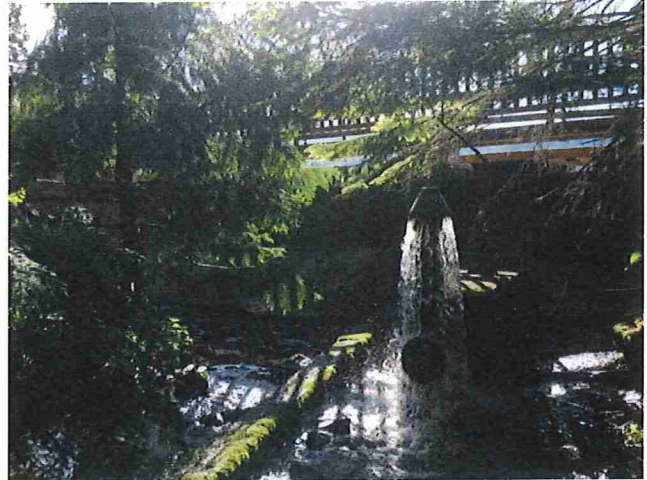
Photo 2: Sasamat Lake outlet June 29

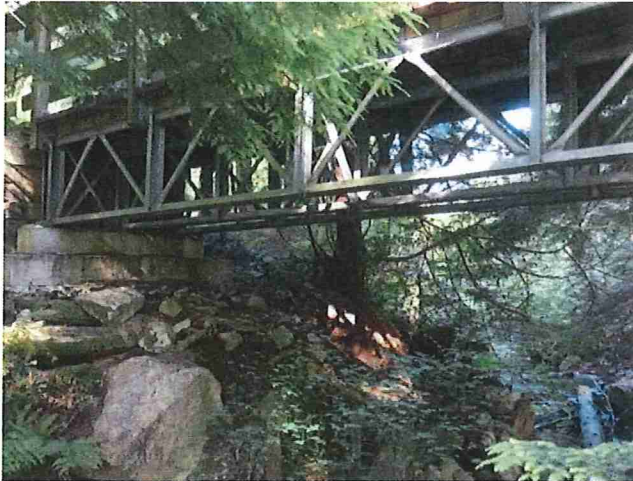
- The bridge has 2.9 m of clearance from the creek bed to the steel girders, and based on visual inspection this appears to be adequate to convey most large flows, though a hydraulic assessment of peak flows has not been completed.
- No material accumulation, erosion, or other issues are apparent at the bridge.
- The creek in this reach is meandering with riffles, pools, and a shallow slope.

Photo 5: Pedestrian bridge to Sasamat Outdoor Centre
June 29

- The bridge hydraulic capacities should be evaluated upon completion of the development of design flows for Windermere Creek (as recommended above).
- **Log Debris Blockage Downstream of Sasamat Lake**

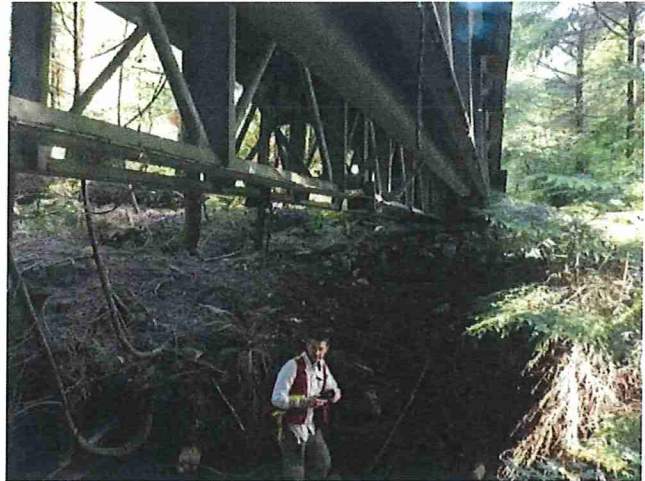
Photo 6: Pedestrian bridge to Sasamat Outdoor Centre
June 29

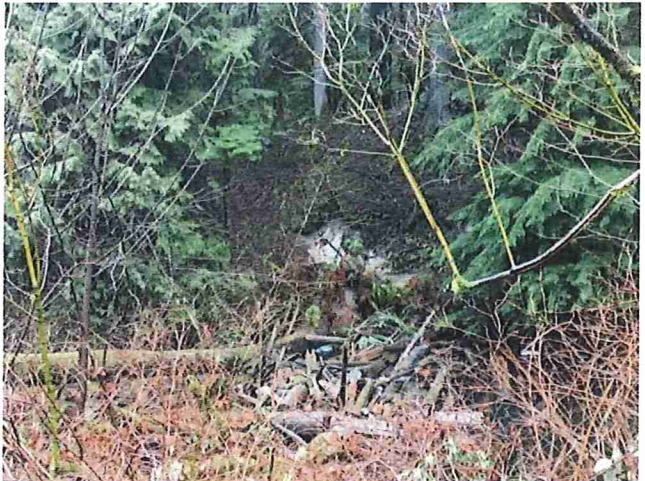
- A fallen tree appears to have pulled away part of the right bank.

- 1.5-2 m (height) of large woody debris (LWD) has accumulated in this location, which spans two-thirds of the creek width. The creek is flowing under the LWD, which was not causing any backwater during the site visits.
- Minor erosion is present along the right bank, which may be caused by the LWD moving with changing creek water levels.
- The LWD blockage and erosion are adjacent to a trail on the left bank and a high steep slope on the right bank that is not close to infrastructure. Based on its location, the erosion and LWD blockage are not significant concerns.

Photo 8: Log debris blockage with fallen tree from right
bank March 3

- Log Debris Blockage Downstream of Sasamat Lake
 - Staff are monitoring the erosion and log debris in this location. This matter will be reassessed after 5 years or after a significant flood event.
 - Staff will remove the Large Woody Debris if the blockage or bank erosion worsens, limiting creek capacity or endangering the road.

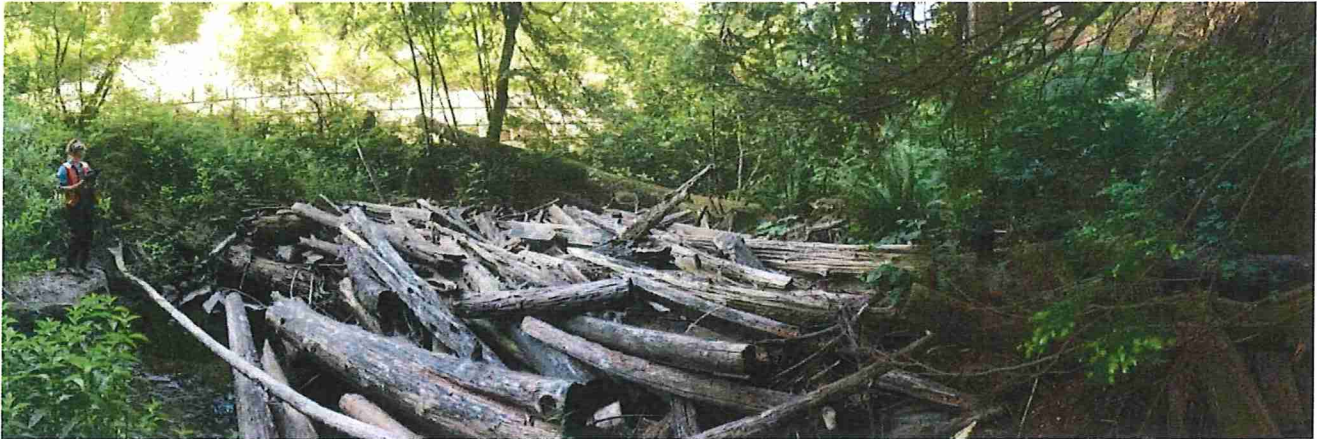
Photo 9: Log debris blockage, looking from right bank to left bank June 29

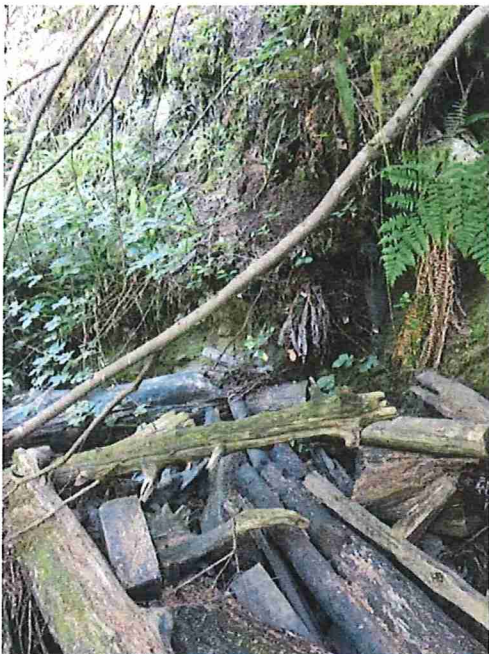
Photo 10: Erosion at toe of right bank adjacent to log debris blockage June 29

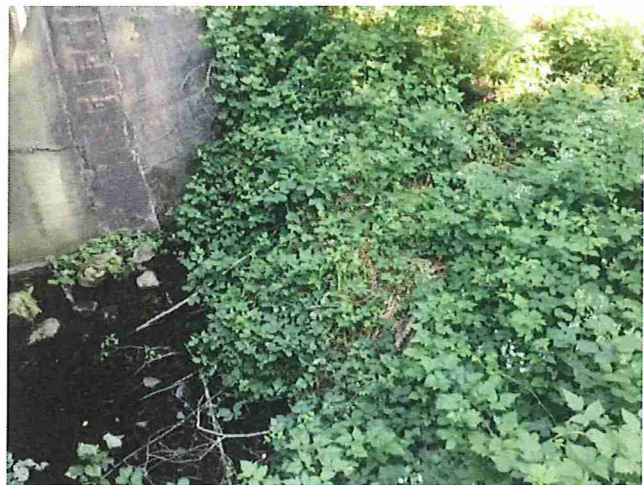
- An old wooden bridge is partially collapsed upstream of the new bridge, with debris accumulating behind and on top of it. Accumulated material could pose a future risk for blockage at the Senkler Road Bridge.
- Two pipes are supported by the bridge and cross the creek below the bridge deck. The bridge has 2.5 m of clearance from the creek bed to the lowest pipe underneath the bridge, and based on visual inspection this appears to be adequate to convey most large flows (provided there isn't a blockage), though a hydraulic assessment of peak flows has not been completed.
- No debris accumulation or erosion issues are apparent at the bridge.
- Downstream of the Senkler Road Bridge, the creek is steeper with cascading pools and large boulders.

Photo 11: Old wooden bridge covered with debris immediately upstream of the Senkler bridge June 29

And that Village staff include in the budget removal of the old logging bridge upstream of Senkler Road Bridge;

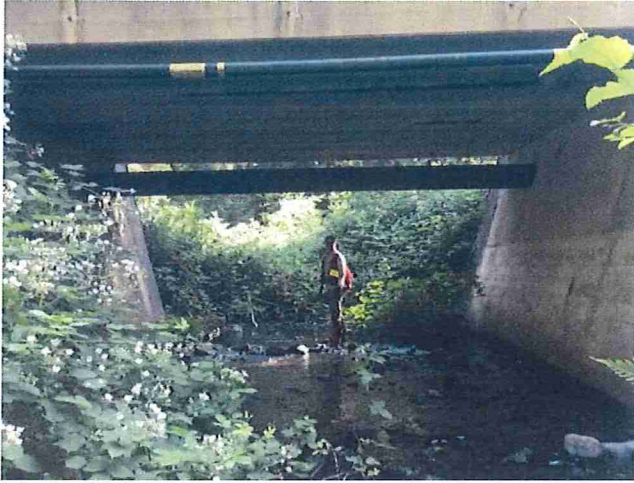
Photo 12: Looking upstream under the Senkler Bridge
June 29

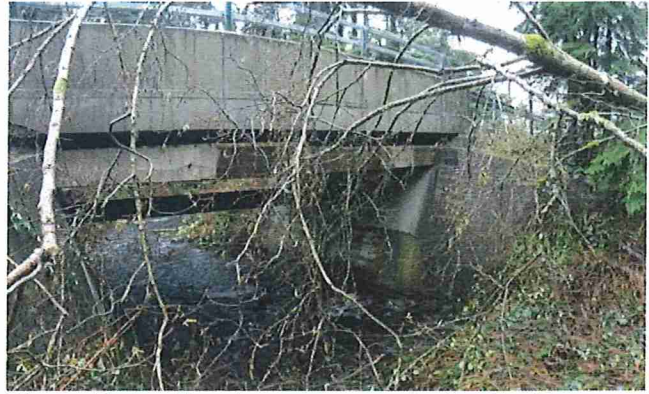
Photo 13: Looking downstream under the Senkler Bridge
March 3

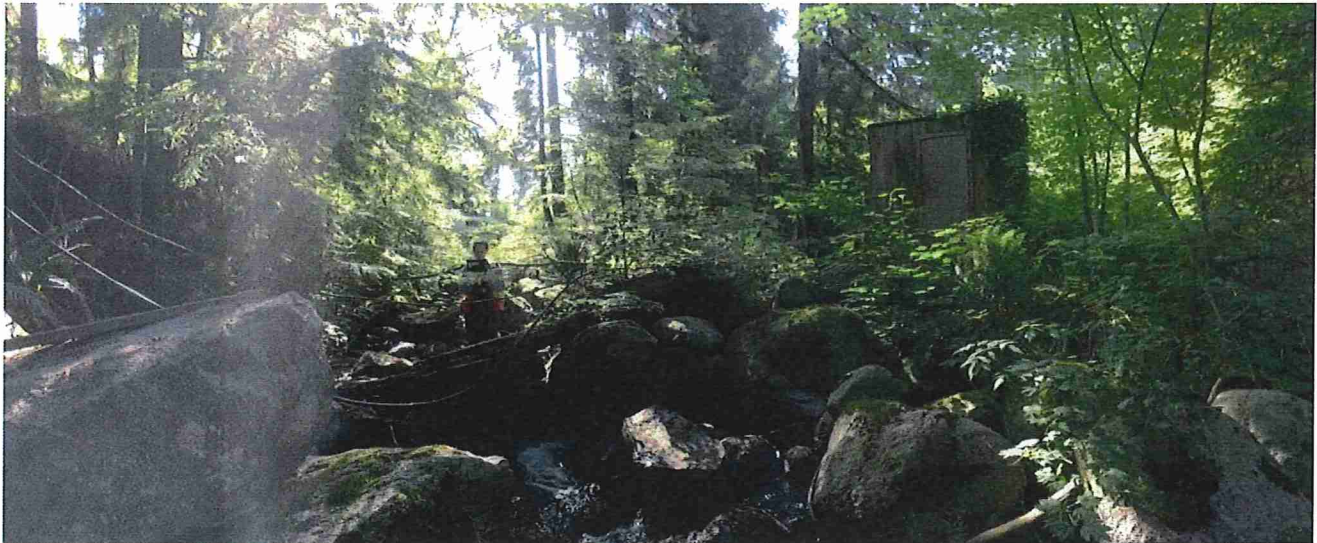
- Multiple small water intakes with pumps, piping, and small sheds are located along the creek from Senkler Road downstream to Bedwell Bay.
- This infrastructure is often in the floodplain, and in some instances the flexible piping crosses the creek and rests on debris in the creek. Low-lying piping and attached equipment could be at risk during a large discharge event.

Photo 14: Water intake lines across creek and shed in floodplain (looking upstream) June 29

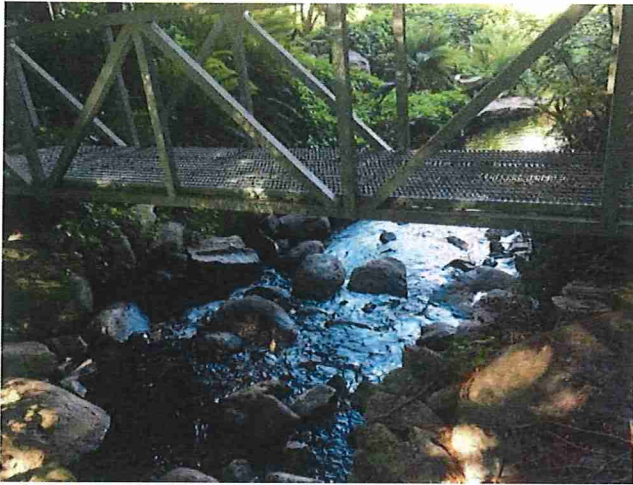
- A small private aluminum foot bridge crosses the creek approximately 100 m downstream of Senkler Road.
- The bridge has 1.4 m of clearance and there is no debris accumulation. Based on visual observations, this bridge has limited capacity, though a hydraulic assessment of peak flows has not been completed.
- Upstream of the bridge, the right bank has some grouted riprap in place.

Photo 15: Private pedestrian footbridge (looking downstream) June 29

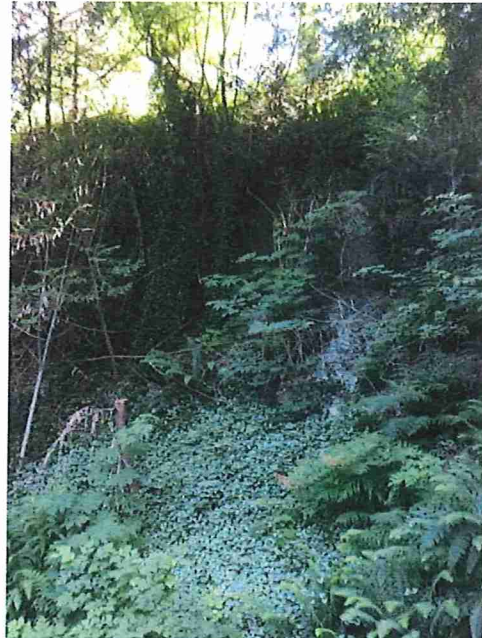
- A short distance downstream of the private bridge described in 2.2.6, the right bank has a high, near-vertical face from a past slope failure (on Block 37 Lots 14 and 4). Most of the toe of the failed slope has vegetation growth and does not have evidence of active erosion. This could pose a risk to existing buildings and infrastructure on nearby properties (Block 37 Lots 5 and 13).
- The total bank height is approximately 8-10 m. The bottom 4-5 m has a 1H:1V slope, and the bank above is vertical with a slight overhang near the top.
- There is erosion at the downstream end of the high cut bank with an undercut tree. There is no obvious nearby building or infrastructure that could be damaged if the tree were to fall.

Photo 16: High failed right bank June 29

- **High Eroded Right Bank (at Block 37 Lots 14 & 4)**
 - A geotechnical engineer should be retained to conduct an assessment of the failed right bank to determine if adjacent properties are at risk (Block 37 Lots 5 and 13).

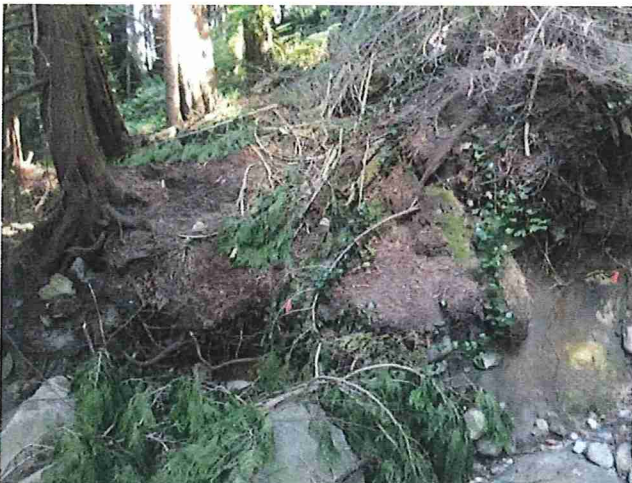
Photo 17: Erosion at downstream toe of failed high right bank June 29

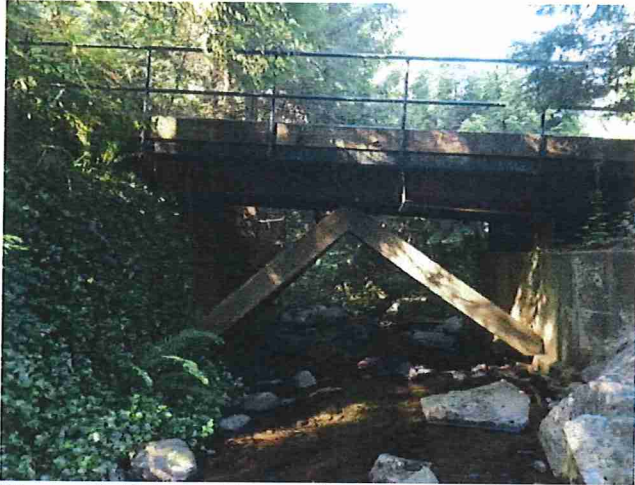
- The driveway bridge has a steel I-beam deck with timber supports that are braced against the creek bed. These timber supports occupy some of the clearance beneath the bridge, which could result in woody debris accumulation.
- Apart from the timber supports, the bridge has 1.9 m of clearance from the creek bed to the underside of the bridge. It is unclear if there is adequate capacity based on visual observations, primarily due to the timber supports within the conveyance channel; however, a hydraulic assessment of peak flows was not completed.
- Some minor erosion is occurring at the downstream left abutment, but it is not significant enough to cause concern for the footings of the abutment at this time.

Photo 19: Private driveway bridge with timber supports (looking downstream) June 29

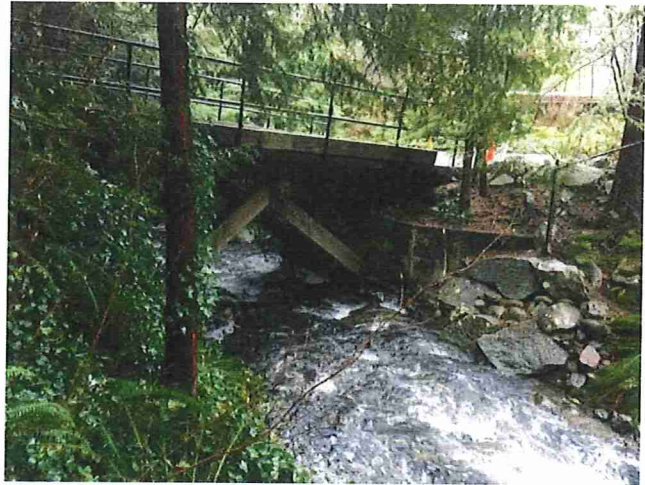
Photo 20: Private driveway bridge with timber supports (looking downstream) March 3

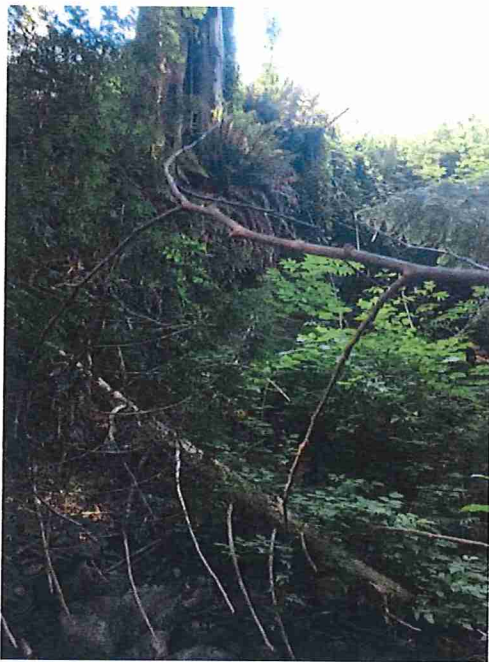
- 20-30 m upstream of the Avalon Creek confluence with Windermere Creek, the left bank has failed and has a vertical face. Along the bank failure, no evidence of recent toe erosion was observed. A house (Block 5 Lot 3) is located close to the top of bank.

Photo 21: Left bank slope failure upstream of Avalon Creek confluence

- **Left Bank Slope Failure Adjacent to Block 5 Lot 3**
 - If not already completed, a geotechnical engineer should be engaged to conduct an assessment of the failed left bank to determine if adjacent property (Block 5 Lot 3) is at risk.

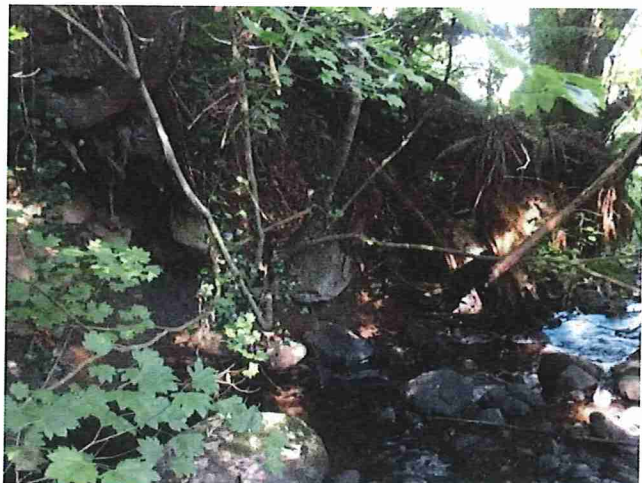
- Downstream of the left bank slope failure, there is erosion at the toe, which has undercut two trees. The undercut trees are directly across from a concrete retaining wall and a property (Block 37 Lot 1) with a house near the creek on the right bank. If the trees were to fall, the house could be damaged.
- The right bank concrete retaining wall along the house (Block 37 Lot 1) appears to be in good condition, but the house is close to the creek and relatively low in elevation. The creek narrows here, suggesting that this reach could be vulnerable to debris blockage. If a blockage were to occur during a flood event, then it may result in floodwaters reaching the house.

Photo 22: Erosion and undercut trees on left bank (looking downstream) June 29

- **Undercut Trees Across from Block 37 Lot 1**
 - An arborist should be retained to assess the two undercut trees on the left bank. Due to the proximity to the house on the right side of the creek, it is likely that the trees will require removal.
 - A flood hazard assessment should be considered, given the relative low elevation of the property, the narrowing of the creek at that location, and the potential for debris accumulation. This location should be monitored during significant flood events.

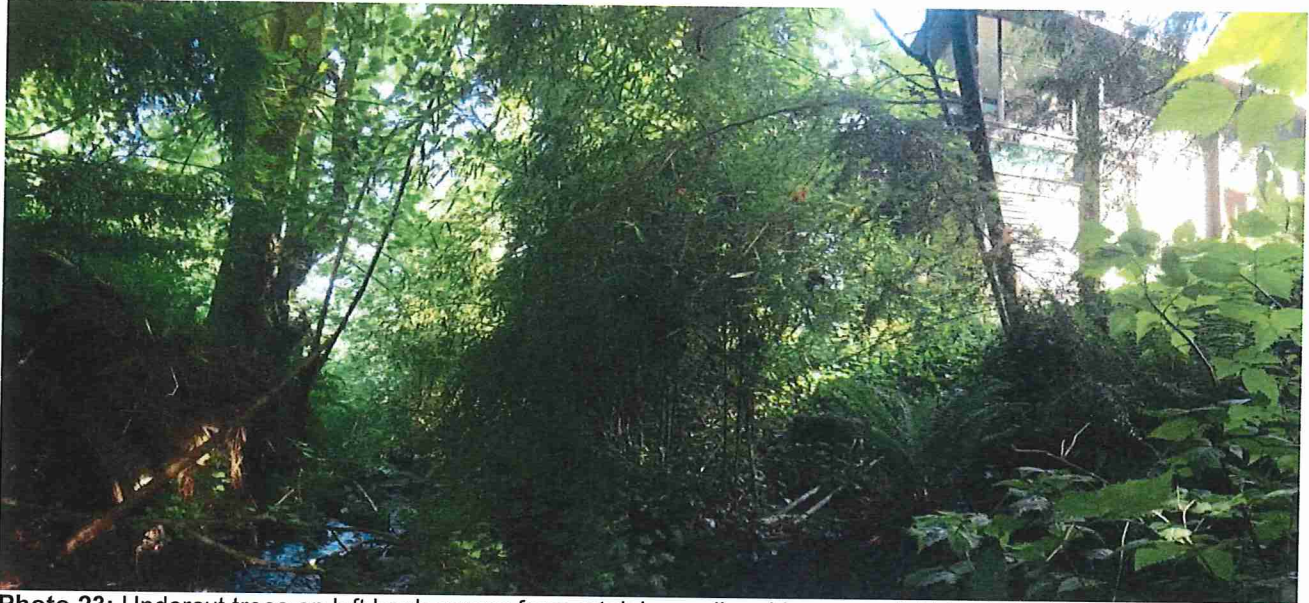
Photo 23: Undercut trees on left bank across from retaining wall and home on right bank (looking downstream)
June 29

- A flood hazard assessment should be considered for the house on Block 37 Lot 1, given the relative low elevation of the property, the narrowing of the creek at that location, and the potential for debris accumulation. This location should be monitored during significant flood events.

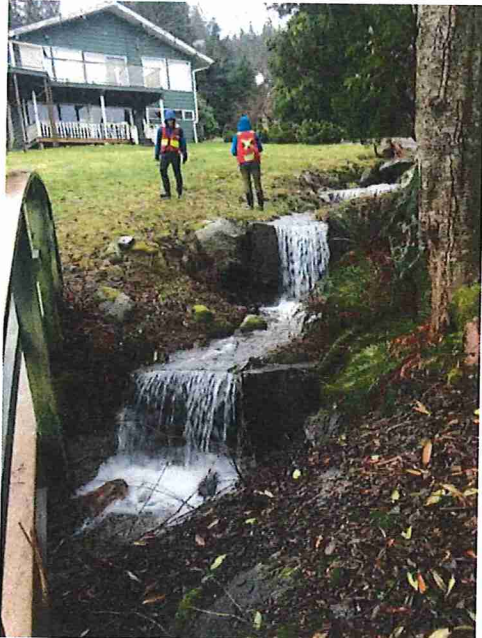
- Concrete step structures were installed in the creek several decades ago from the culvert outlet to the existing pedestrian bridge (possibly installed by the property owner). The works are failing due to significant erosion of the fine bank material on Avalon Creek, which is very steep from the culvert to Windermere Creek.
- The ground on the left side of the creek along the concrete step structures is low and slopes to the north.

Photo 24: Concrete step weirs on Avalon Creek
upstream of private footbridge March 3

- In the long term, removal of the failing creek works (concrete step structures) should be considered to avoid debris accumulation in Windermere creek downstream and development of creek stabilization design options, as the exposed banks and bed would be susceptible to accelerated erosion following structure removal.

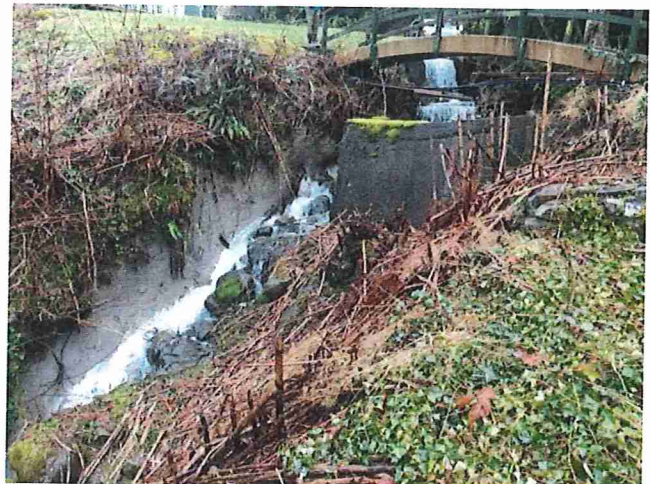
- The concrete step structure beneath the private pedestrian bridge is undercut, and directs the creek flow to the right bank (comprised of fine erodible material), which shows evidence of significant erosion. Some minor undercutting was also noted at the concrete step structure immediately upstream of the bridge.

Photo 25: Eroded right bank on Avalon Creek
downstream of private footbridge March 3

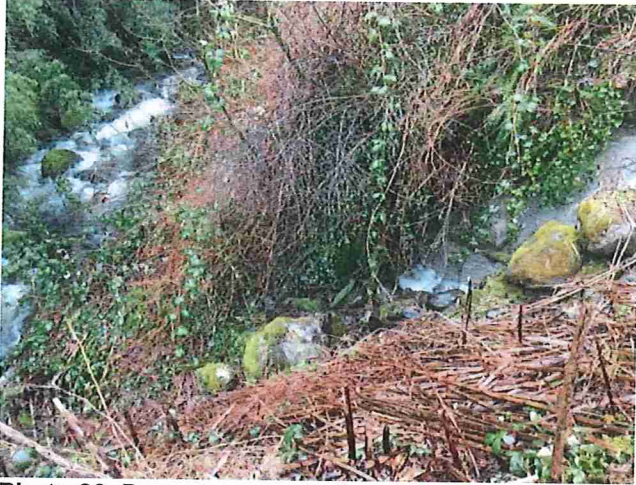
Photo 26: Downstream end of eroded right bank on Avalon Creek above confluence March 3

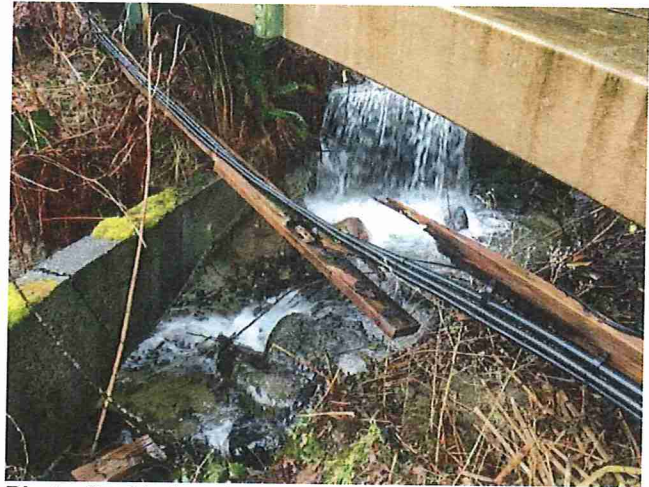
Photo 27: Undercut concrete weir downstream of private footbridge with hanging cables March 3

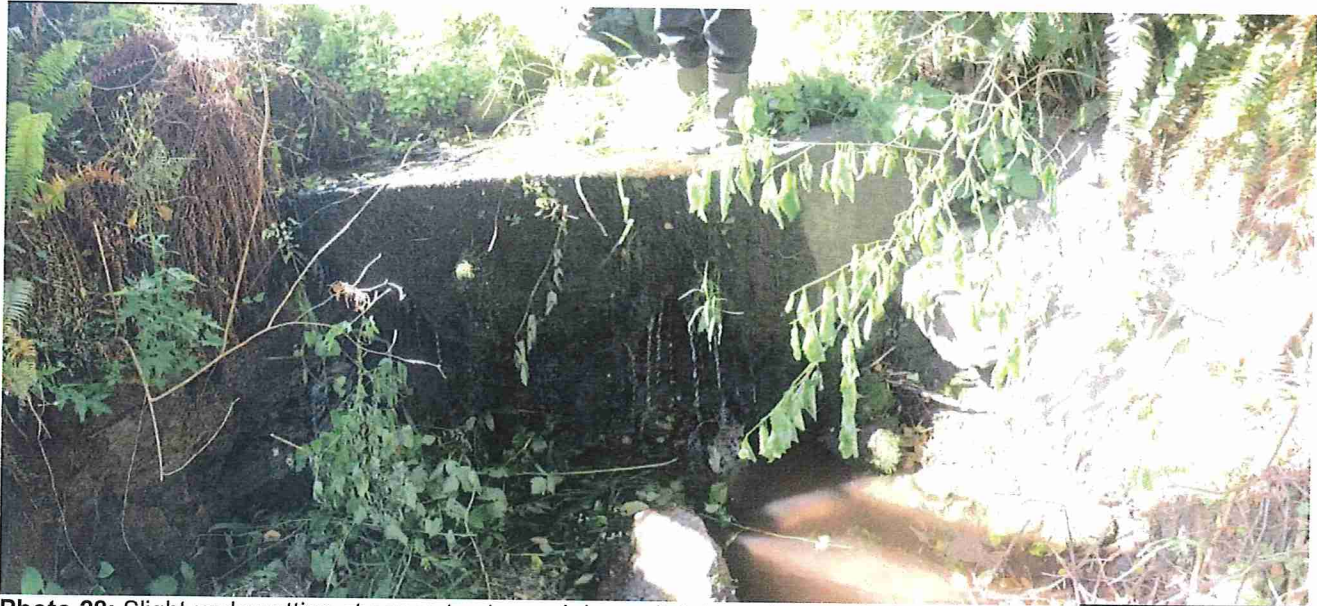
Photo 28: Slight undercutting at concrete step weir immediately upstream of private footbridge on Avalon Creek

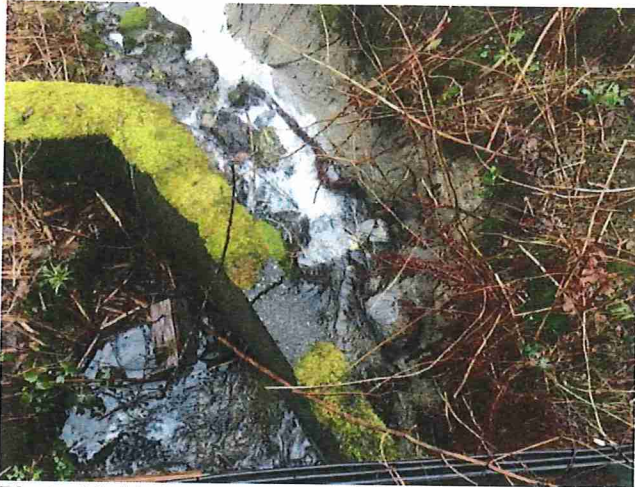
Photo 29: Undercut concrete weir downstream of private footbridge (looking down from bridge) March 3

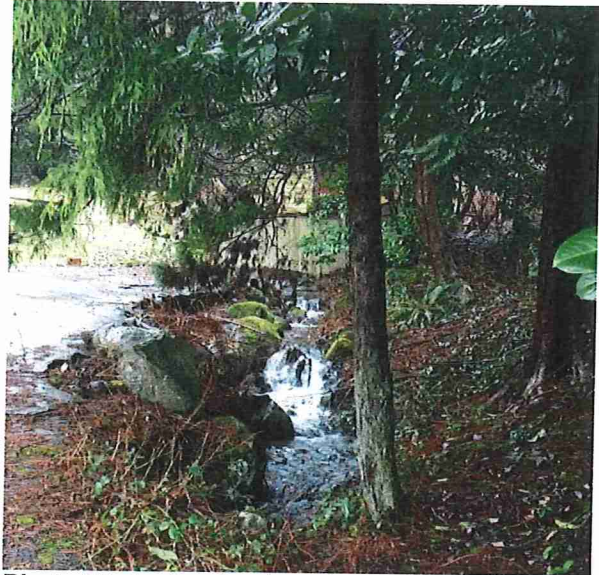
- There is an existing 450 mm (internal diameter) concrete culvert under a driveway entrance (Block 5 Lot 3) at the end of Tatlow Trail. It is reported that the culvert has only overflowed over the road when debris has blocked the culvert.
- Upstream of the culvert, the channel dimensions range from 1.5-1.8 m wide at top of bank, 0.5-0.7 m deep, and approximately 0.9 m wide at the base of the creek with a slope of approximately 14%.

Photo 30: Avalon Creek upstream of existing 450 mm culvert March 3

- A hydrologist should be retained to develop design peak discharges for Avalon Creek and the small drainage proposed to be diverted to it. This would be required to assess whether the existing culvert on Avalon Creek upstream of the pedestrian bridge has sufficient capacity, as well as provide information for the design of the proposed pedestrian crossing (culvert or bridge) for the new trail. This work could be done as a part of a drainage study the Village is planning to commission this year.
- Given the degree of creek erosion and the slope failure on the adjacent property, a geotechnical engineer should be retained to assess the long-term stability of the slope near the eroding creek banks at the existing private pedestrian bridge and provide geotechnical guidance and recommendations for the new pedestrian crossing.
