## **SASAMAT VOLUNTEER FIRE DEPARTMENT (SVFD) BOARD OF TRUSTEES MEETING**

##### **3.1 SVFD Fire Hall Replacement – Village of Anmore and Village of Belcarra**

issued: 2019-04-18

# anmore and belcarra firehalls condition and needs assessment

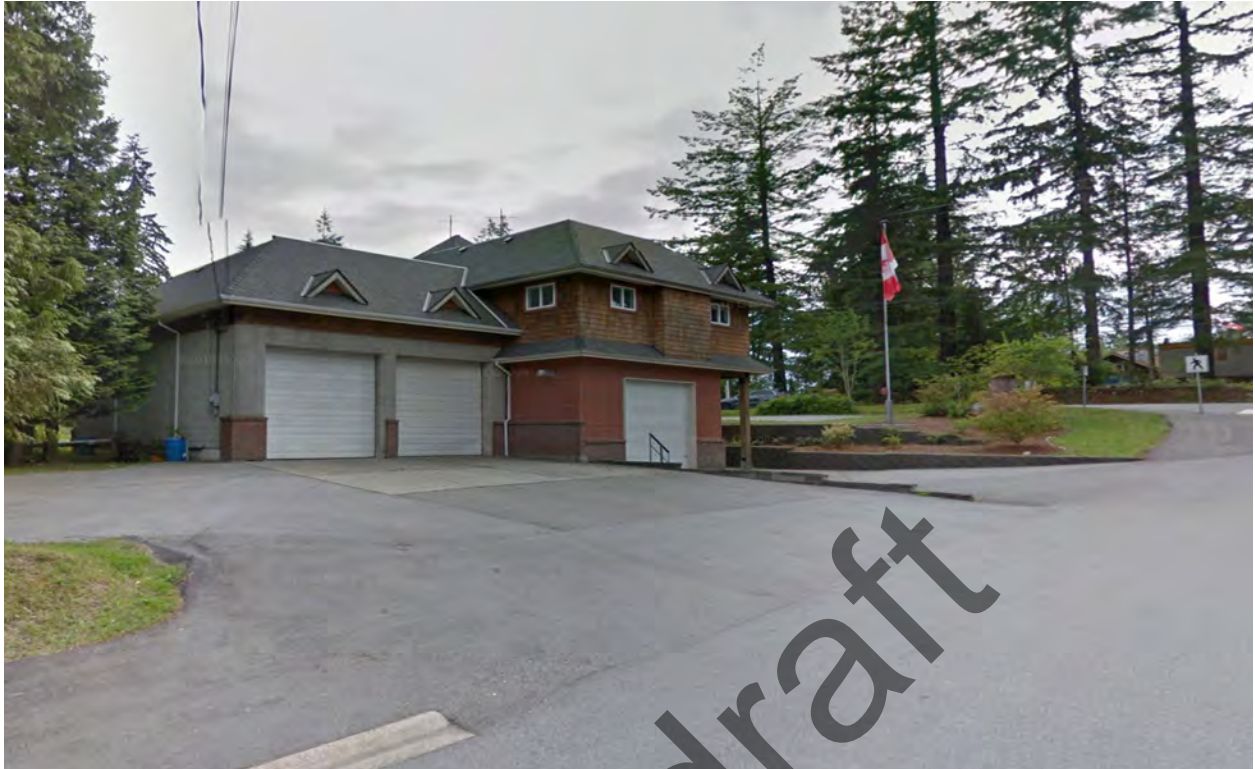
Exterior view of the Anmore Firehall from northeast corner of the site from E Road. This Firehall was constructed in 1977 and consists of 3 apparatus bays, training tower and reception.

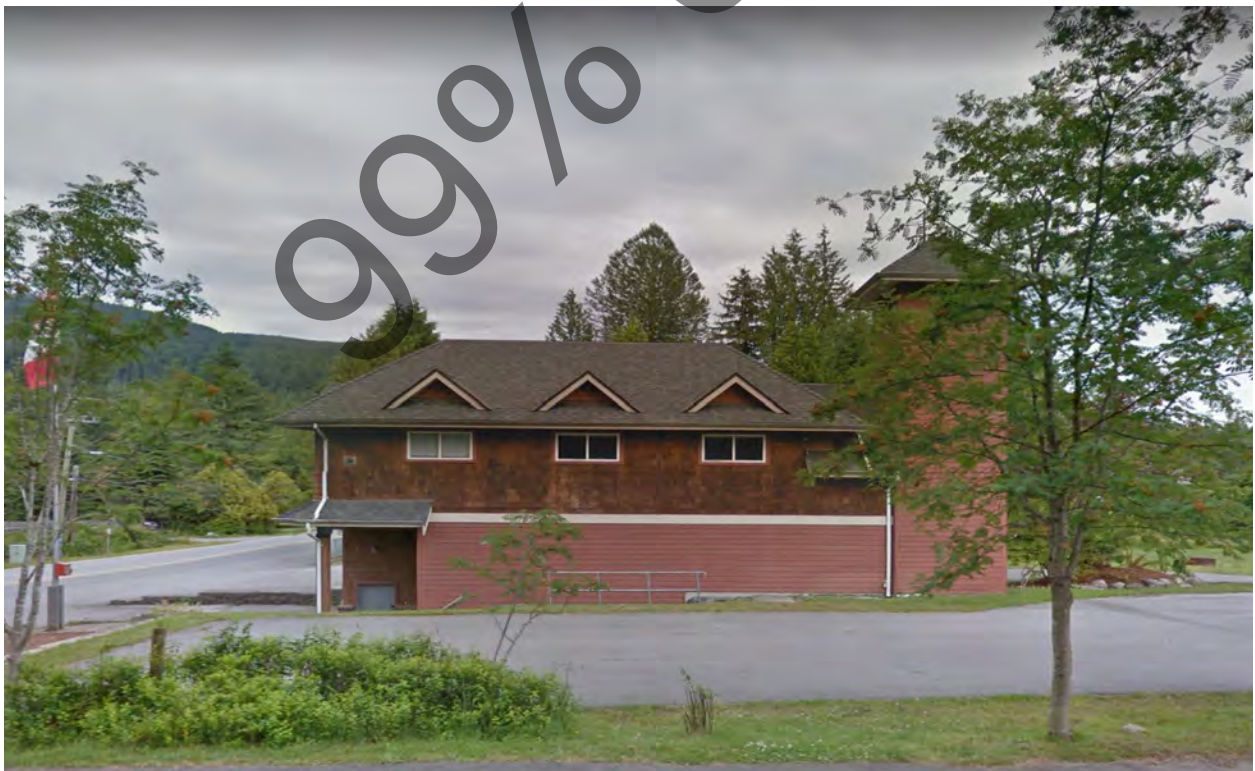
Exterior view of the Anmore Firehall from western side of the site along Sunnyside Road.

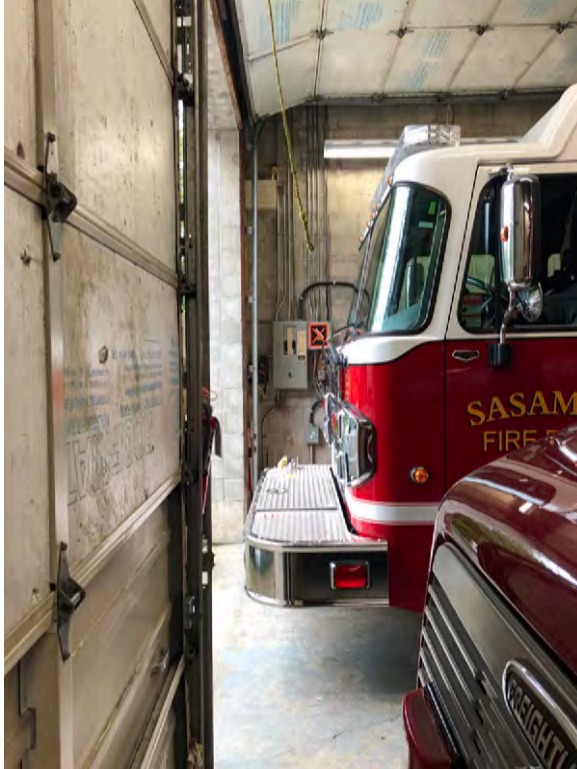
Apparatus bays with extremely limited space between vehicles and doors.

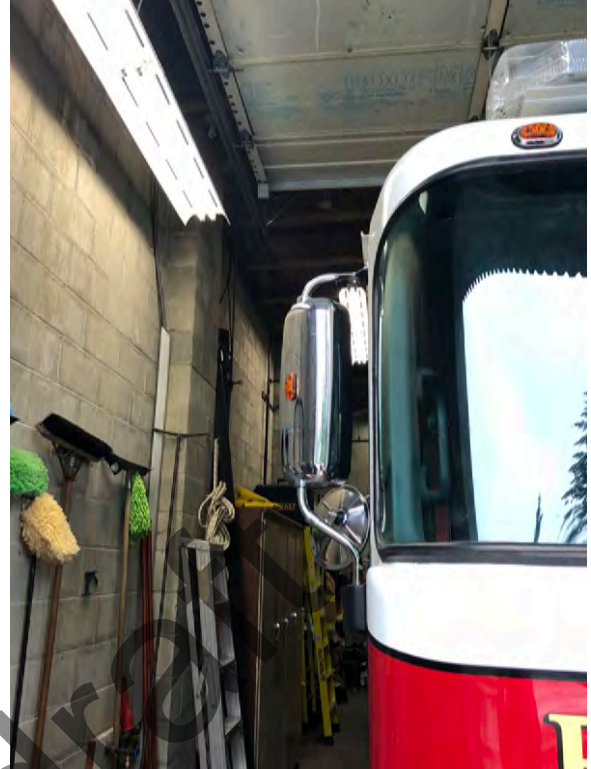
Equipment and materials stored between vehicles and wall space, making walkway narrow.

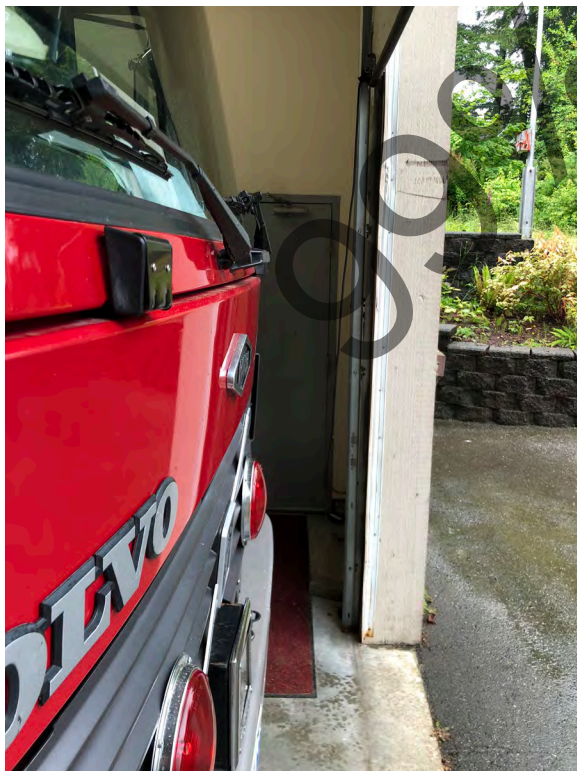
Less than 2 feet of space between apparatus and overhead door when closed.

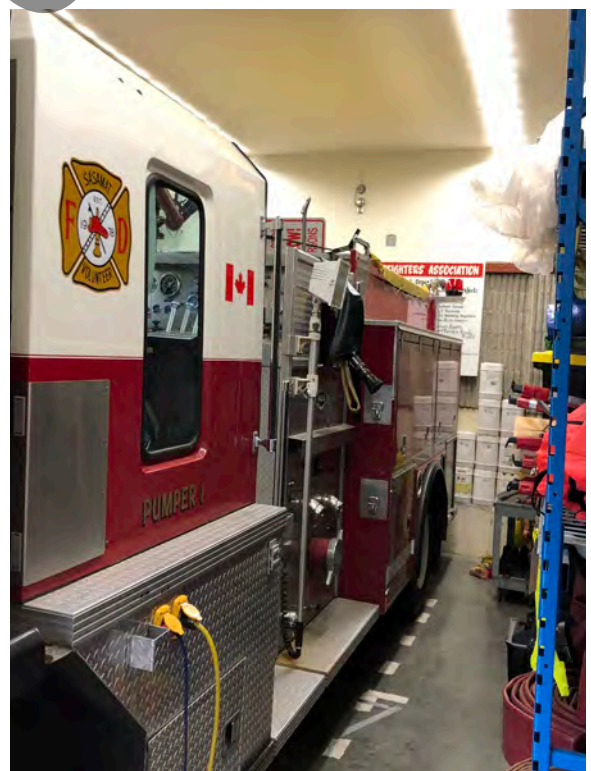
Circulation space around vehicles is inadequate and compromises personnel safety when trying to access vehicles quickly during an emergency

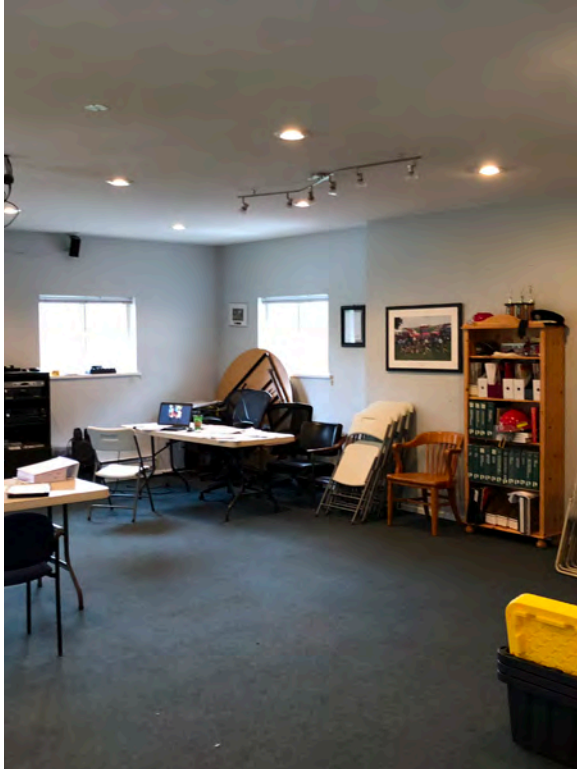
Training Room has limited areas to store tables and chairs.

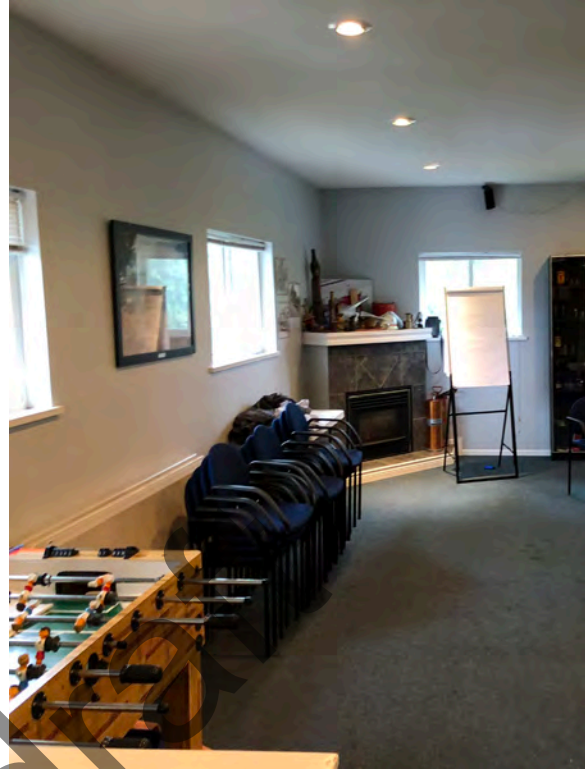
Day Room doubles as dining room, located on second floor of building.

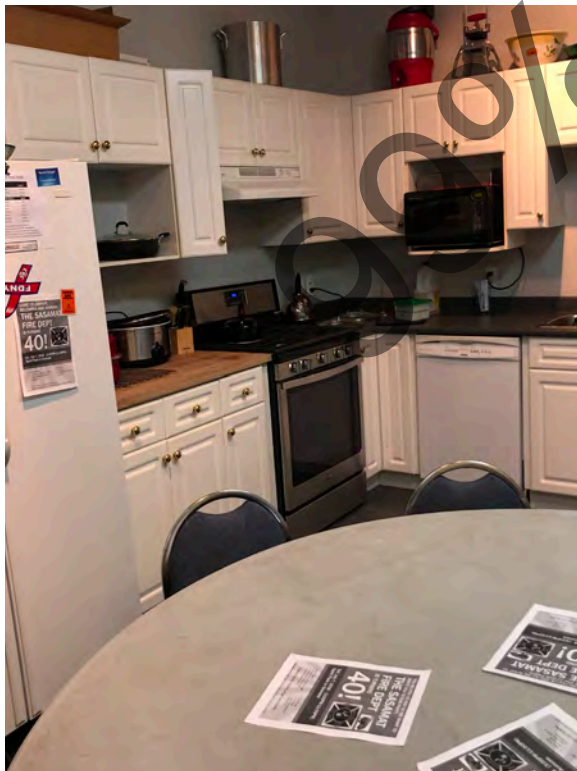
Existing counter/kitchen space is limited for a department of this size, small food preparation and mealtime area.

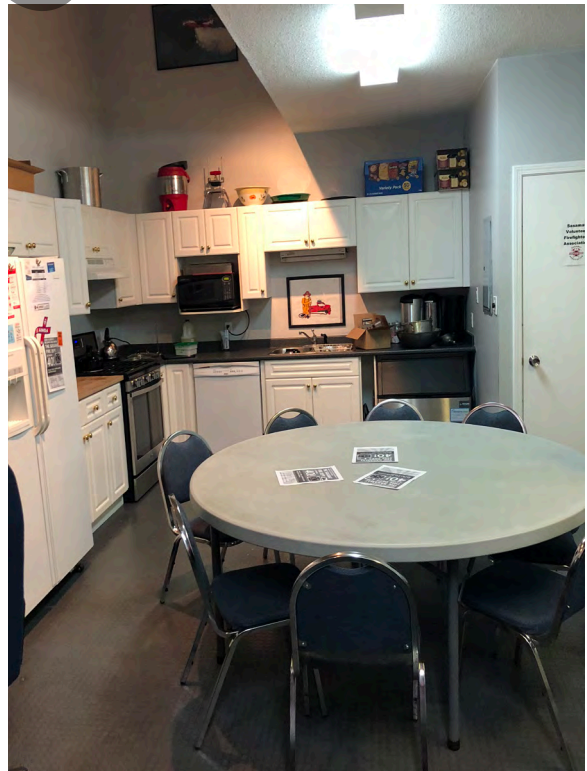
Limited area throughout kitchen/dining area, potential to be easily crowded.

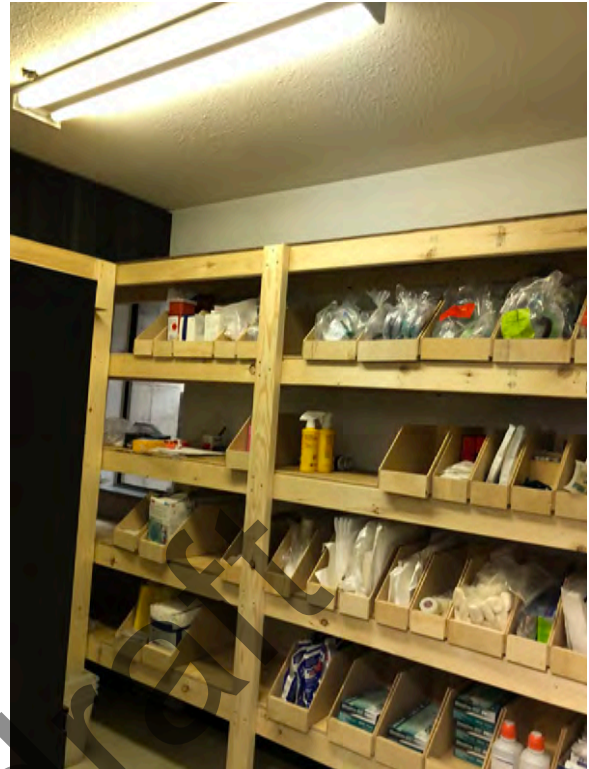
Low-quality lighting in makeshift storage areas, options for storage include utilizing underused spaces.

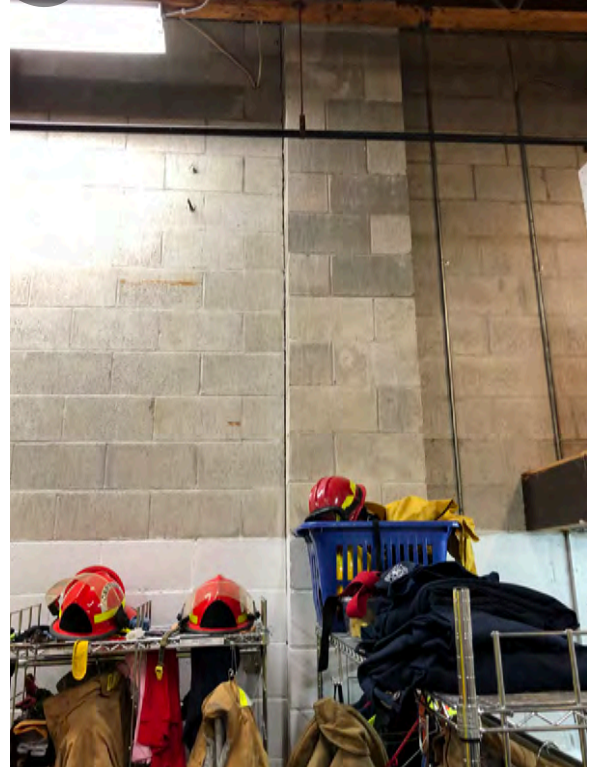
Limited structural capacity leading to cracks and structural deficiencies in walls.

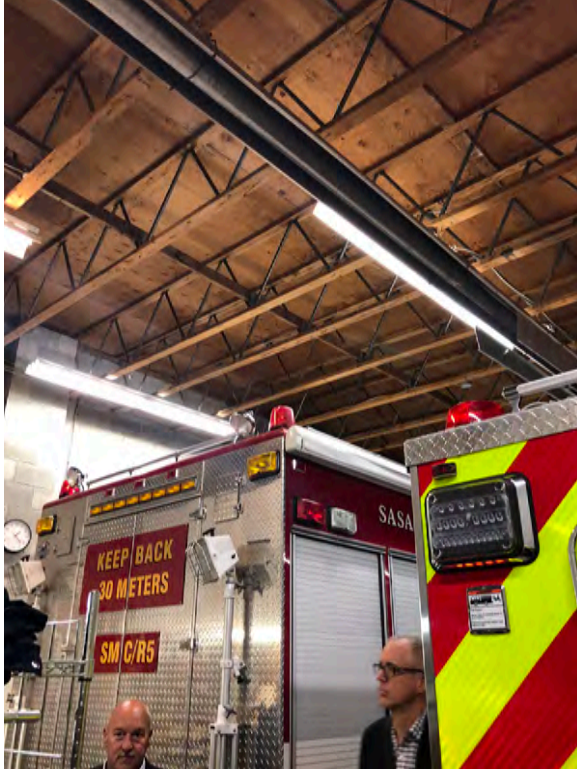
Exposed ceiling structure requires fire-rated enclosure.

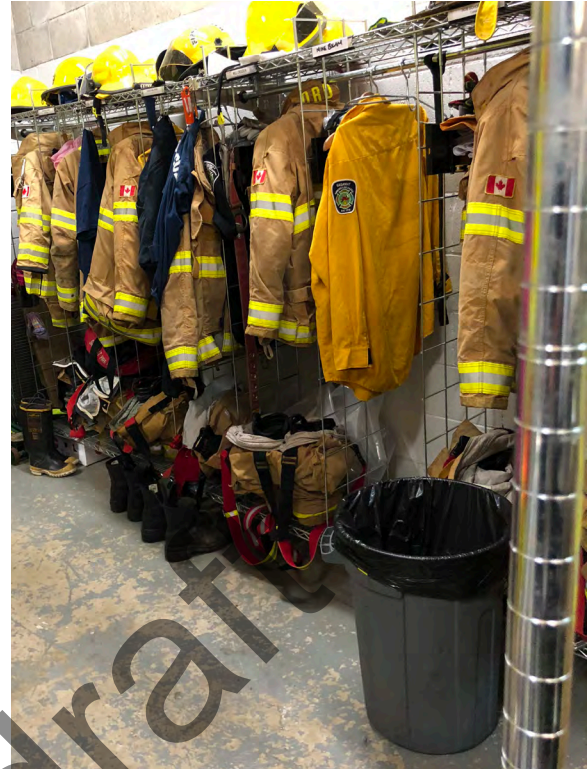
PPE area located within the apparatus bays instead of separate room. Limits movement around vehicles

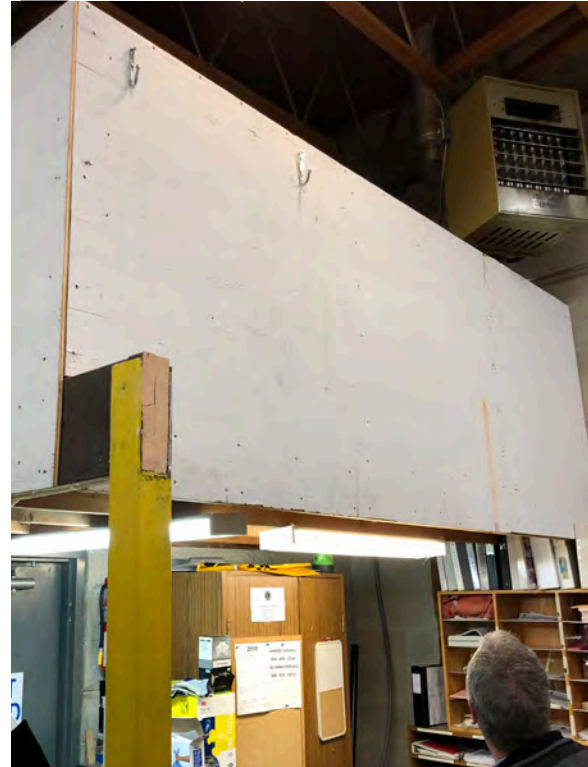
Makeshift storage located above filing area, not structural sound for post-disaster requirements.

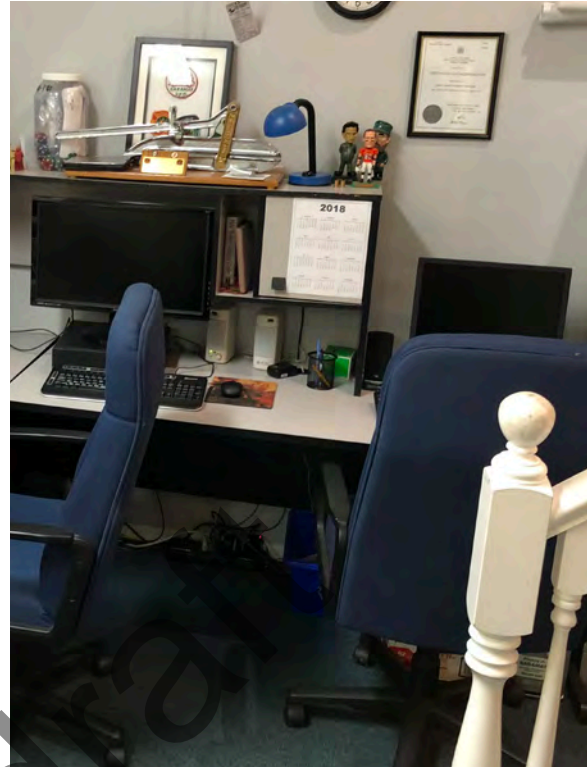
Additional office space located at upper floors and limited to small area. Little area to display awards

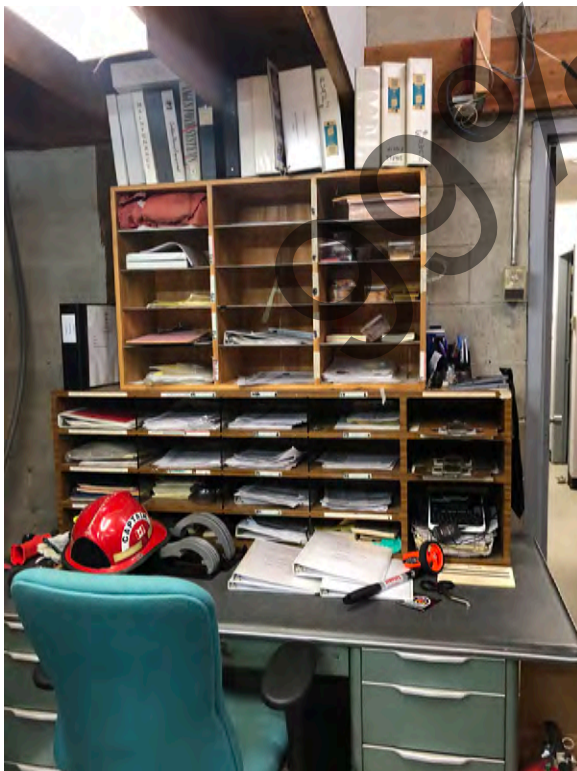
Filing / desk area located directly within apparatus bays with exposure to noise and contaminants.

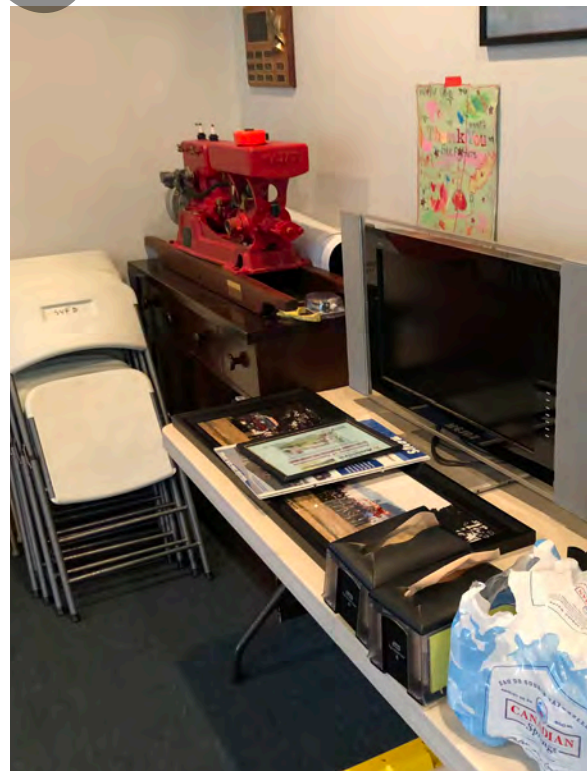
AV storage within the training room.

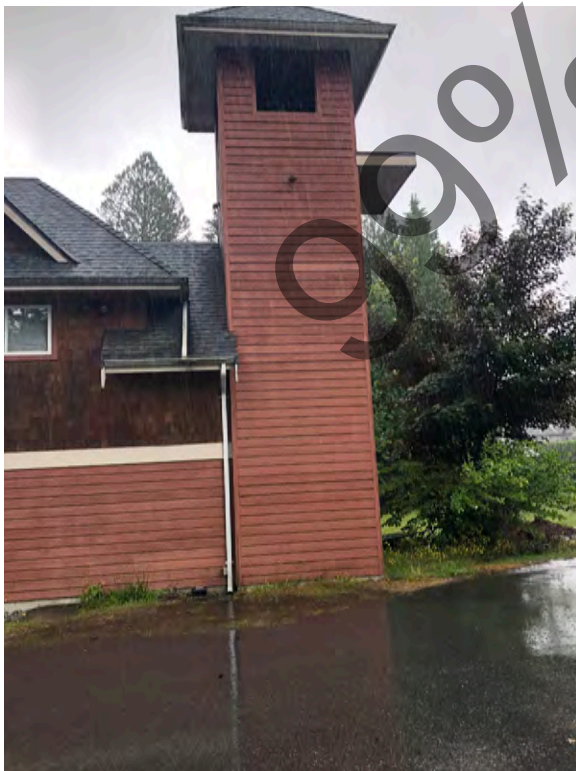
Training tower no longer usable for training, exterior wood panelling worn by elements.

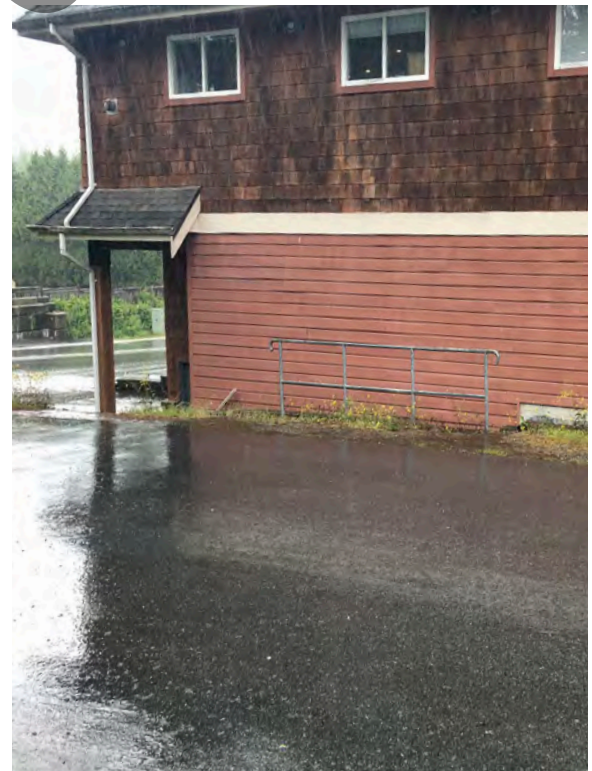
Exterior wood panelling worn by elements.

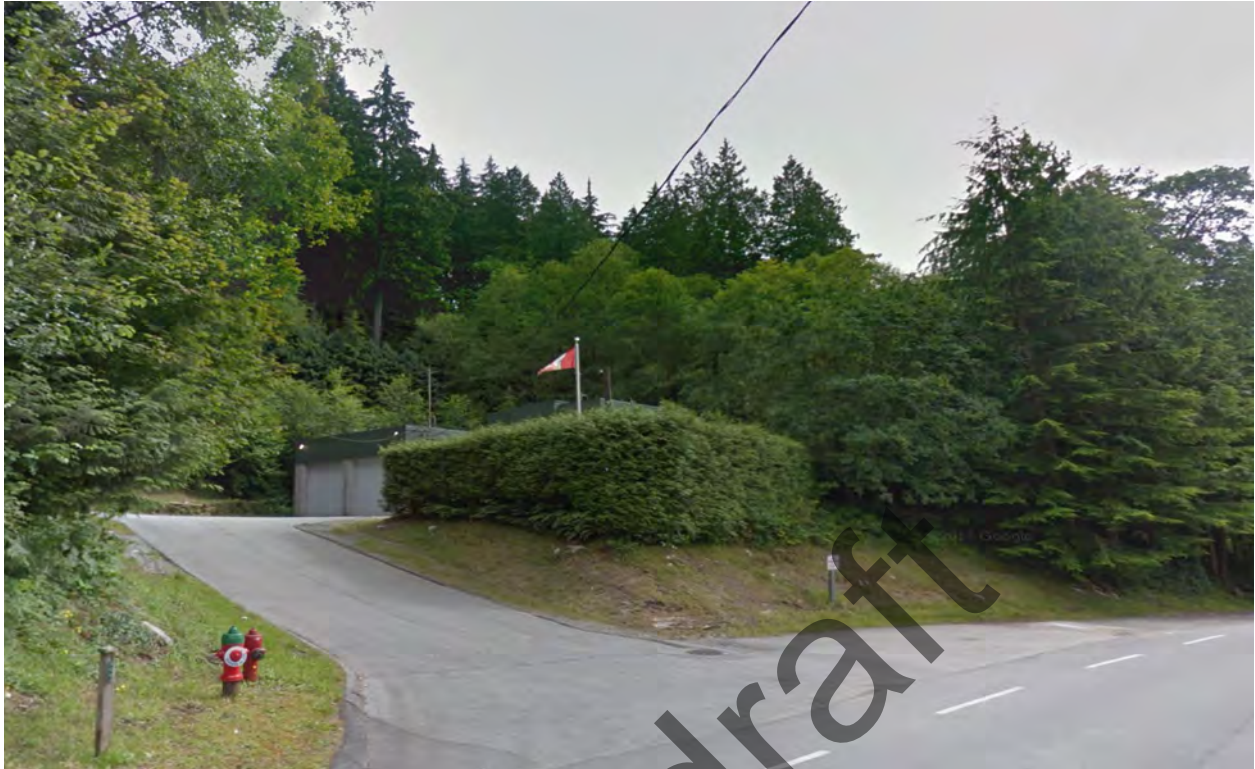
Exterior view of the Belcarra Firehall facing southwest along Bedwell Bay Road. This Firehall was constructed in 1977 and consists of 2 apparatus bays.

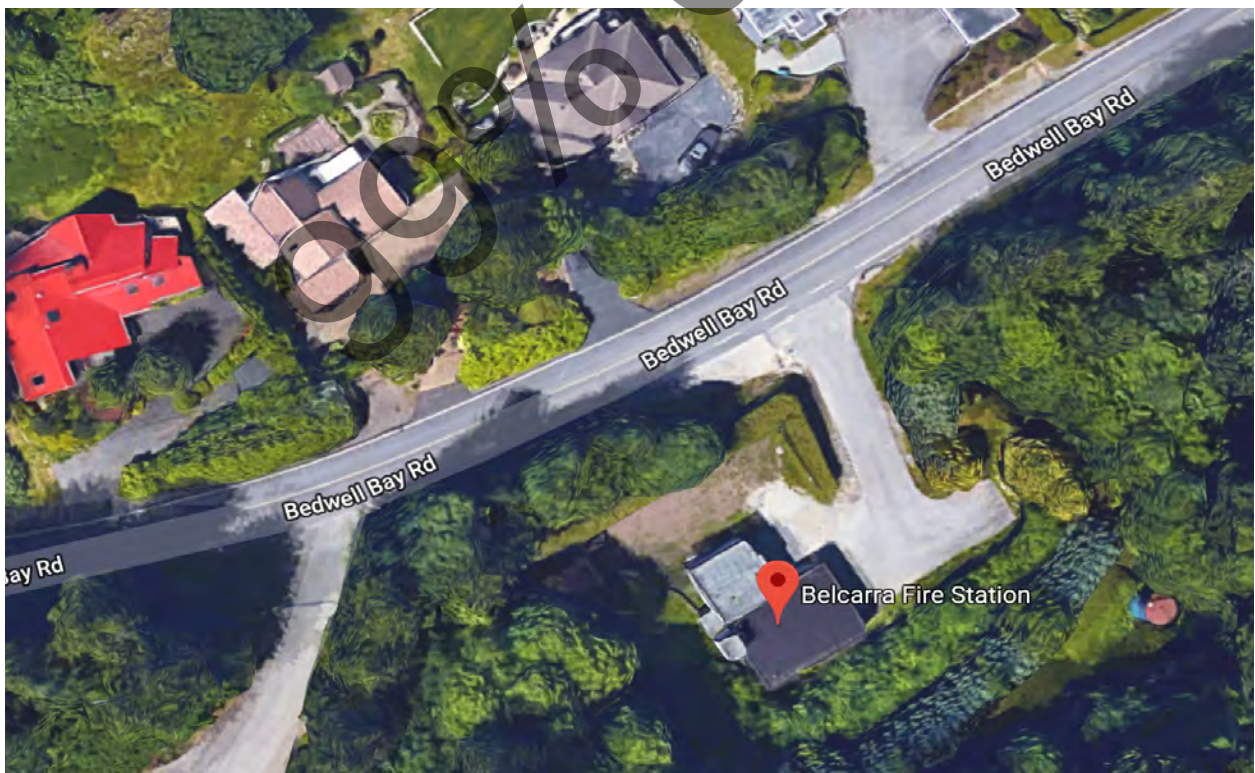
Aerial view of the Belcarra Firehall, fire trucks entering and exiting the premises encounter a sloped driveway from Bedwell Bay Road.

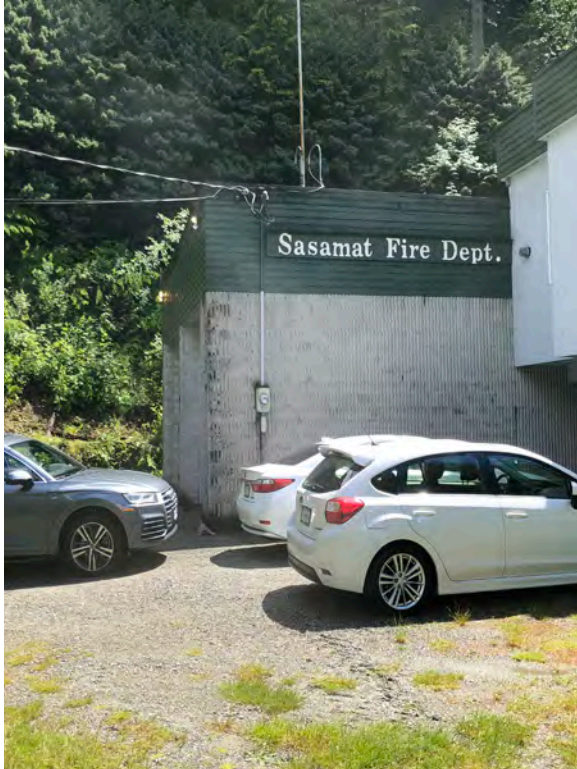
Exterior of building has not been renovated since 1977.

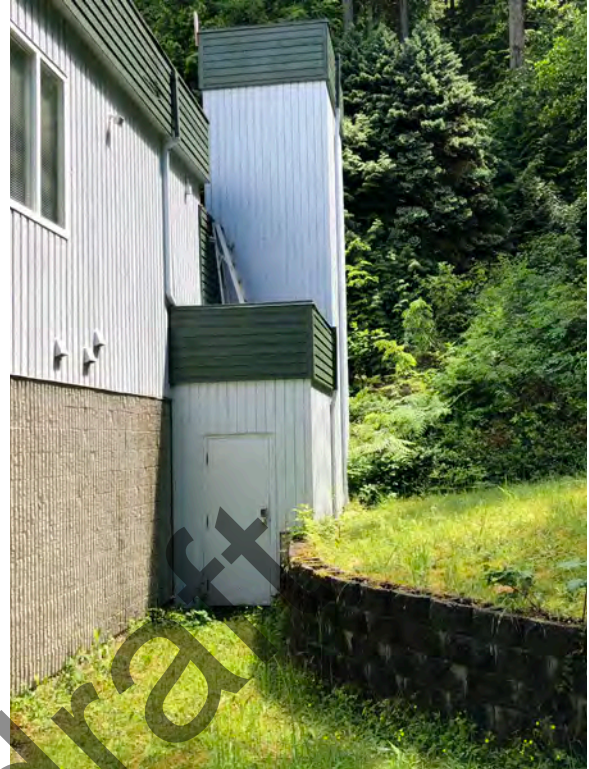
Small training tower added in 1997 along with SCBA facilities.

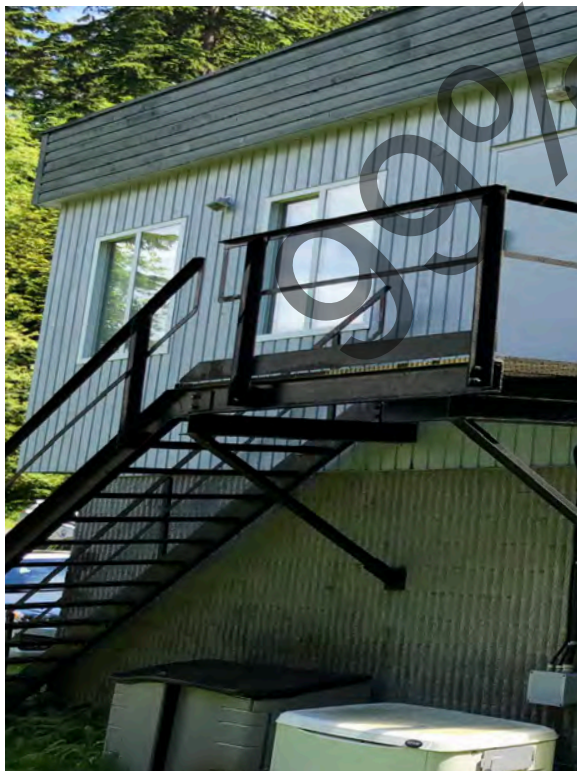
Exterior metal stairs and entrance walkway.

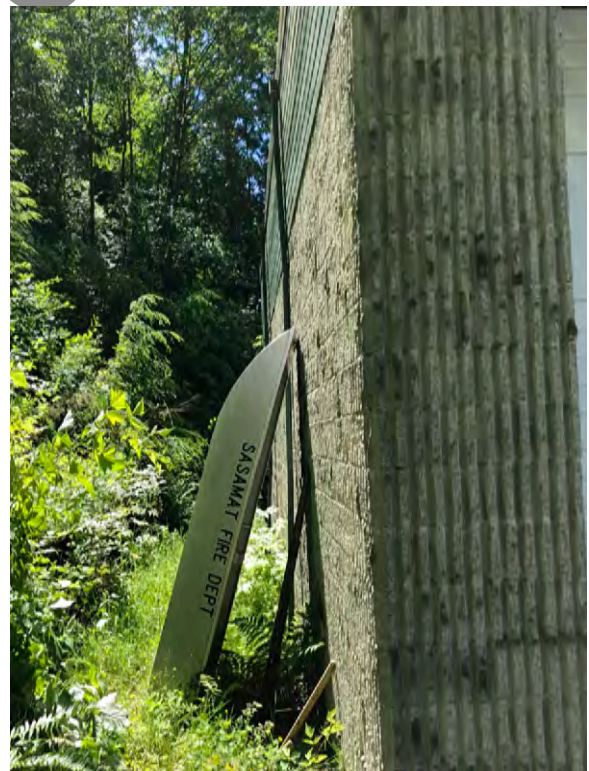
Response equipment and storage space for memorabilia limited.

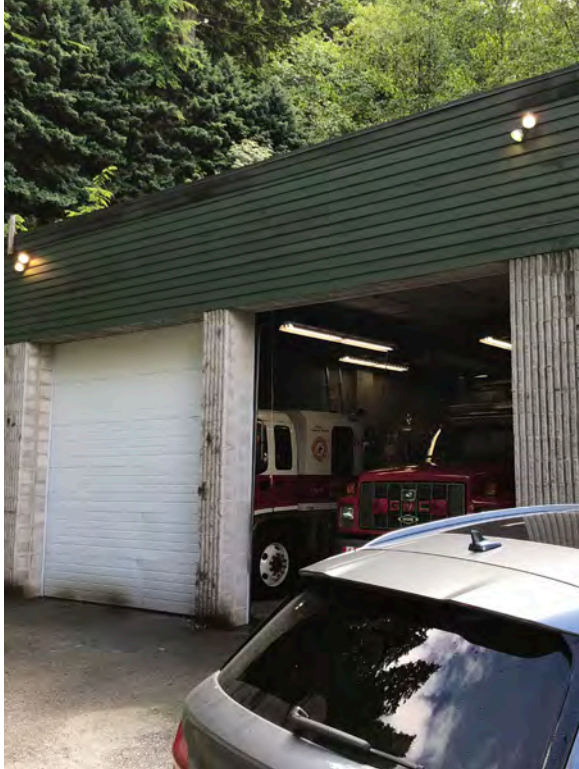
12' apparatus bay doors with less than adequate space for fire trucks.

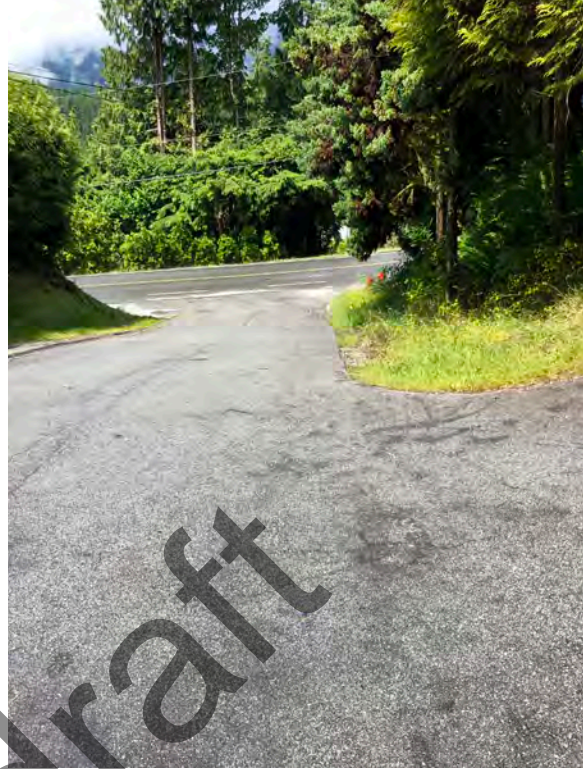
Sloped driveway with limited vision of traffic along Bedwell Bay Road - road approach at 8.3%

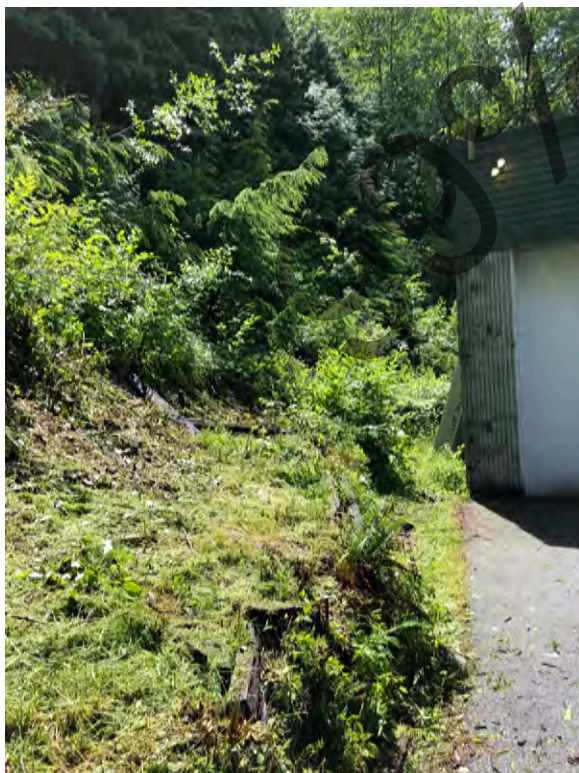
Firehall located against steep terrain with no retaining wall or slide protection.

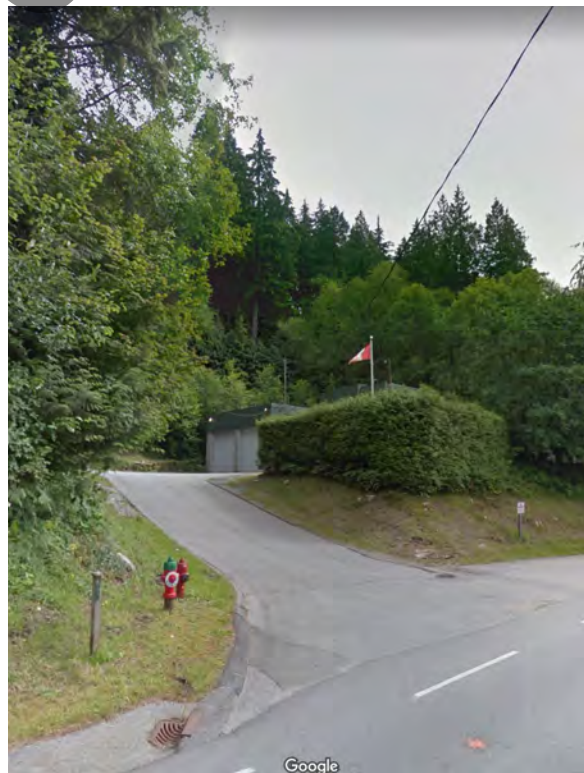
Steep slope and difficult turning radius for apparatus.

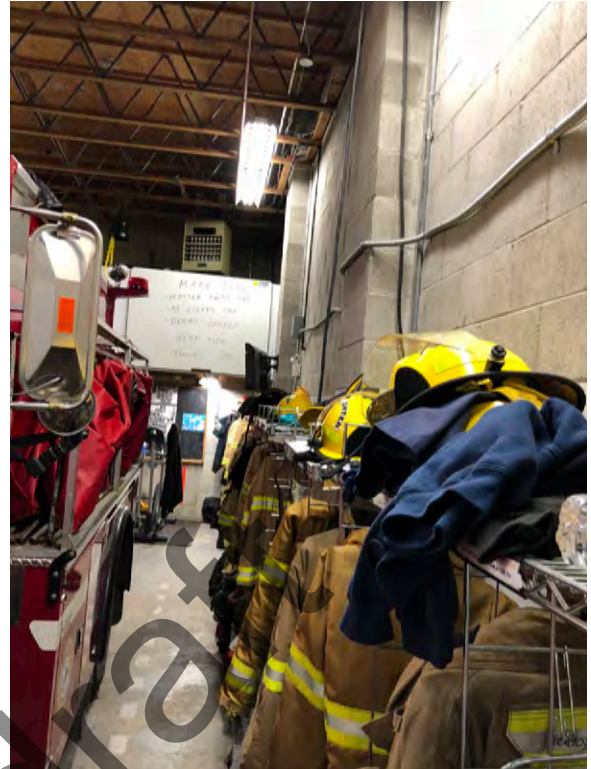
PPE hanging area is small for department size, also set to dry in apparatus bays and exposed to vehicle contaminants.

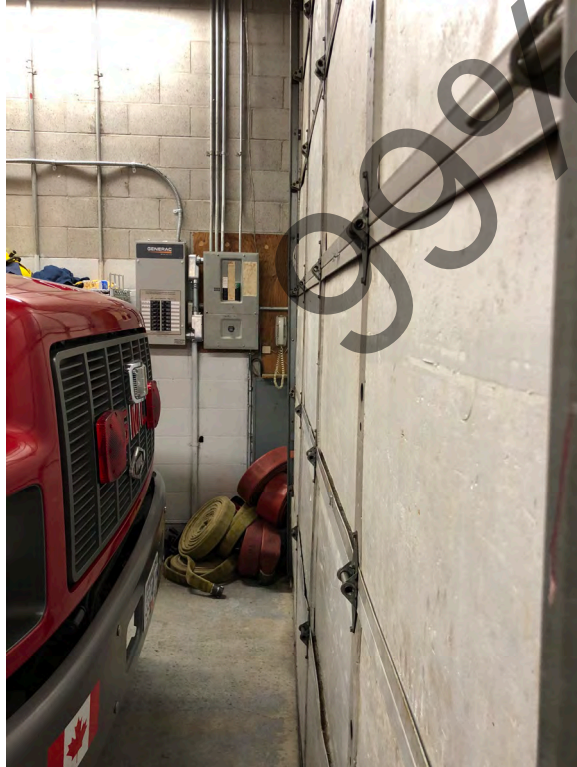
Circulation space around vehicles is inadequate and compromises personnel safety when trying to access vehicles quickly during an emergency.

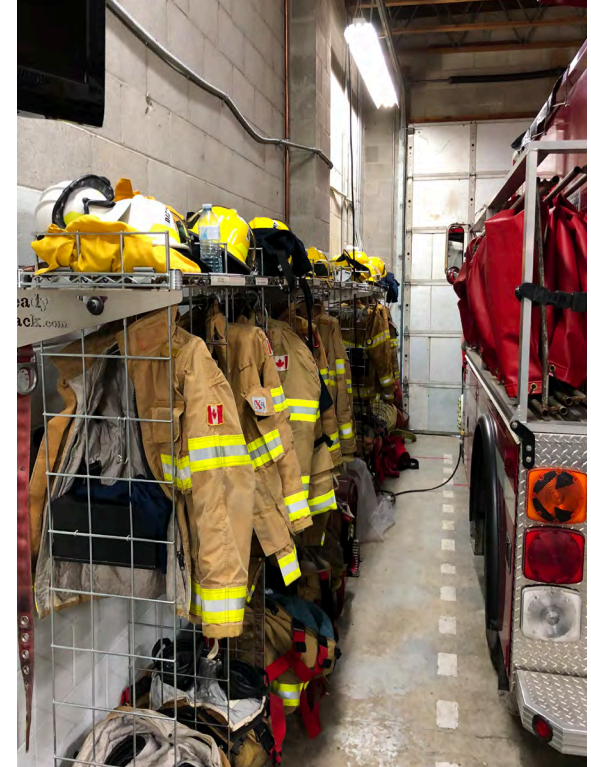
PPE storage located with apparatus bays - limiting access to and around vehicles. this also places gear with the same space as the vehicles which exposes them to further contaminants once they have been cleaned and does not allow for them to dry effectively.

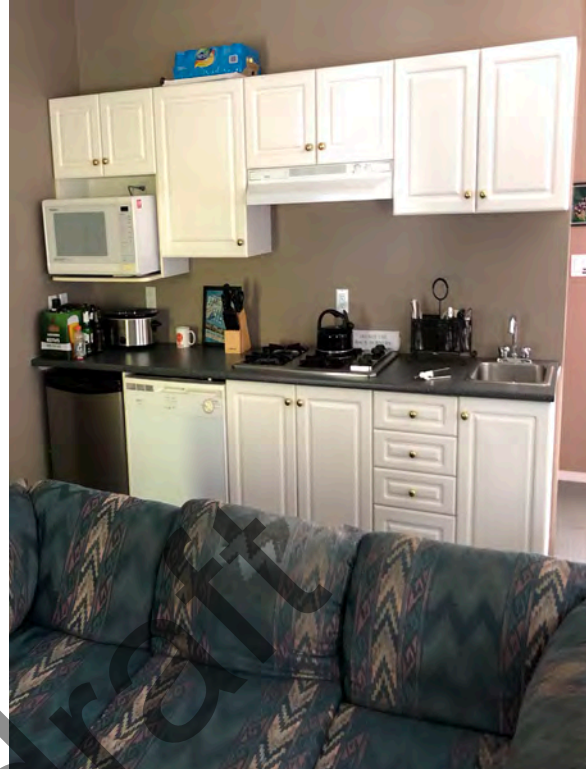
Day Room and kitchen within limited shared space.

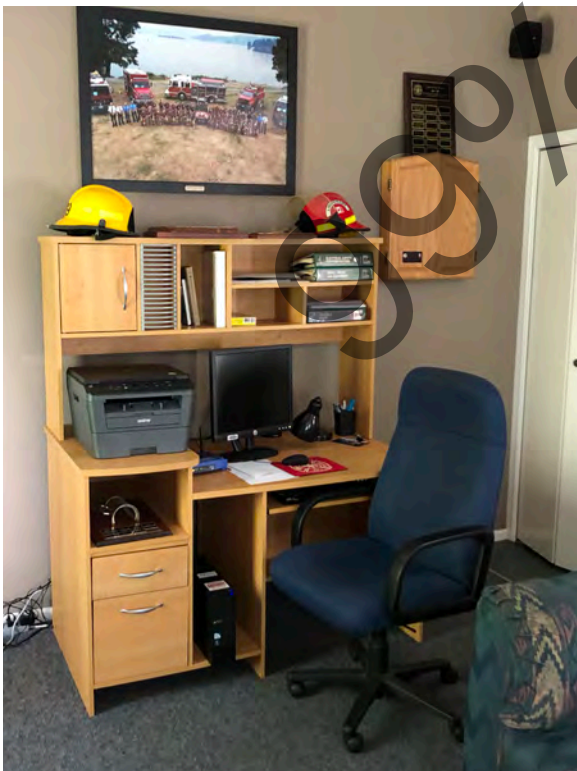
Day Room and office area combined into a singular space.

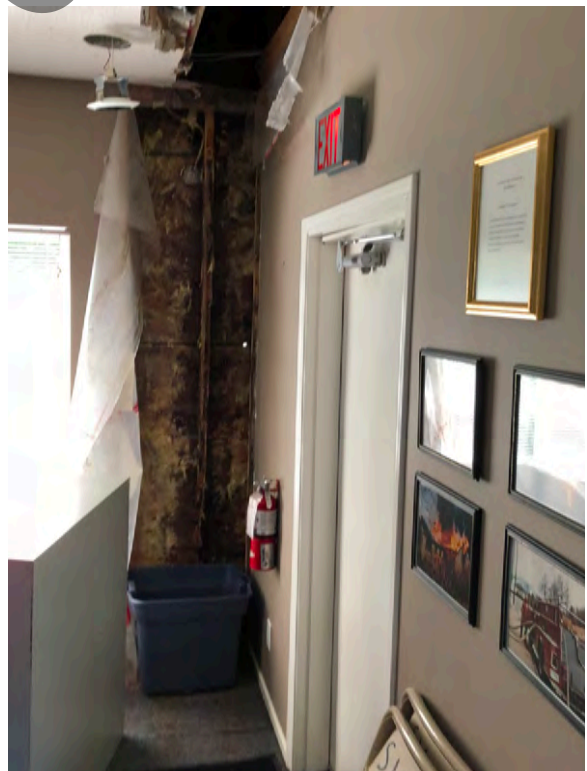
Infrastructure is suffering from ongoing water ingress.
