VILLAGE OF BELCARRA
2018 Environmental Projects
Final Environmental Monitoring Reports -
Letts Environmental (attached)

**FINAL ENVIRONMENTAL MONITORING REPORT**

Re: Bridge removal and Riparian Planting at Senkler Road in Belcarra BC.

Re: Culvert installation within Avalon Creek as part of the Tatlow Trail construction between Watson Road and Marine Avenue in Belcarra BC.

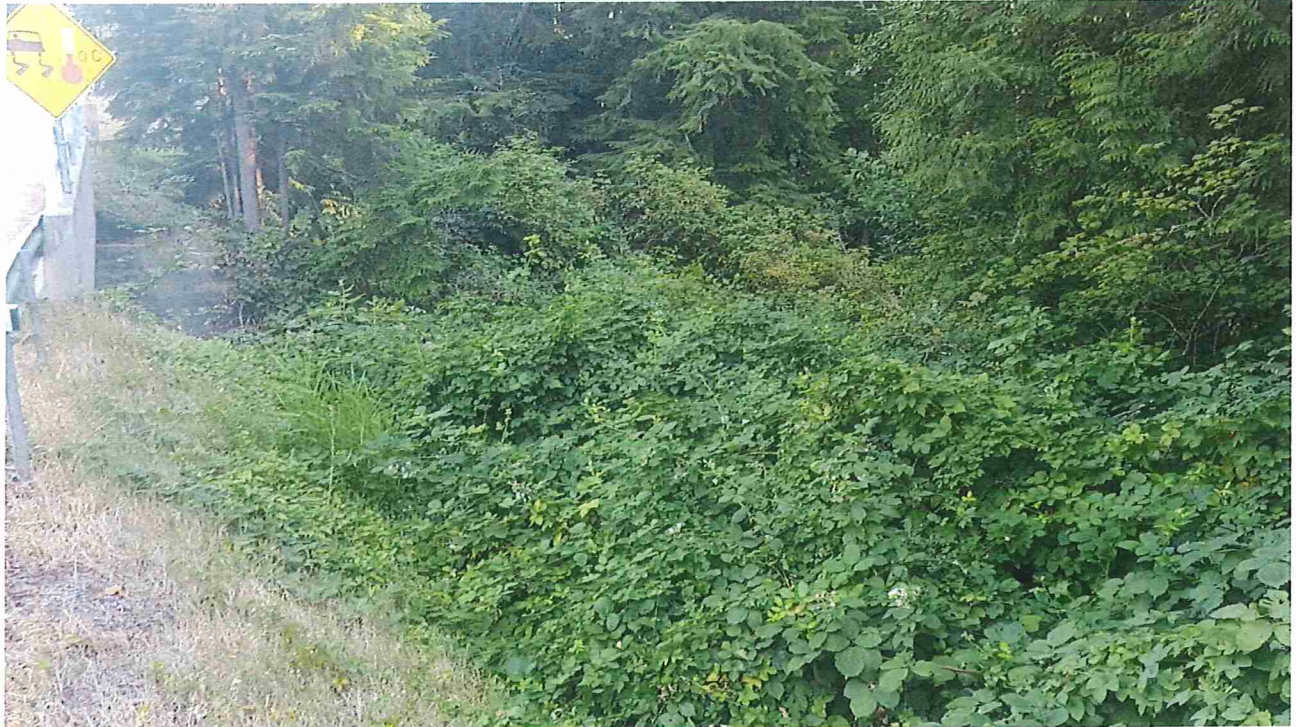
Photo 1: Site prior to works occurring.

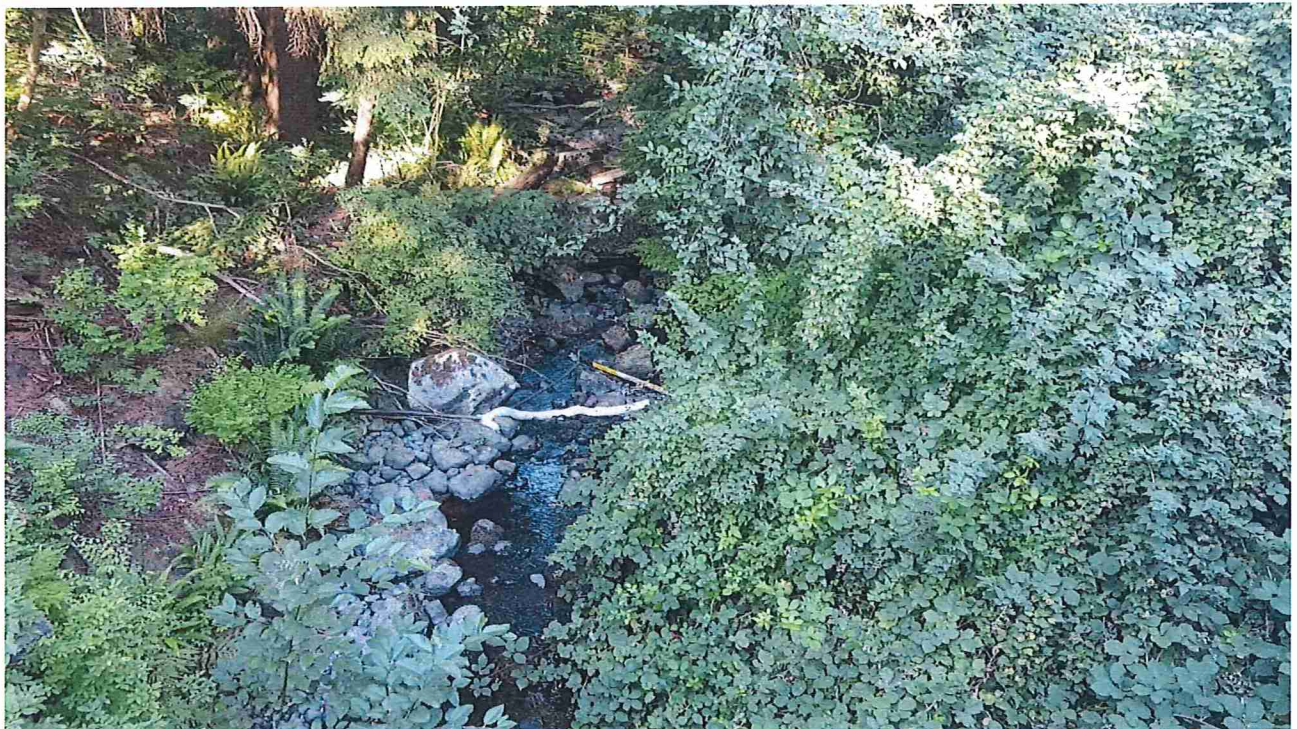
Photo 2: Installation of sediment control measures downstream.

Works commenced on August 7, 2018 under clear conditions. Low flows were noted within the watercourse. A cotton boom was set up within the creek downstream of the workzone to ensure any sediment laden water generated as part of these works did not migrate downstream.

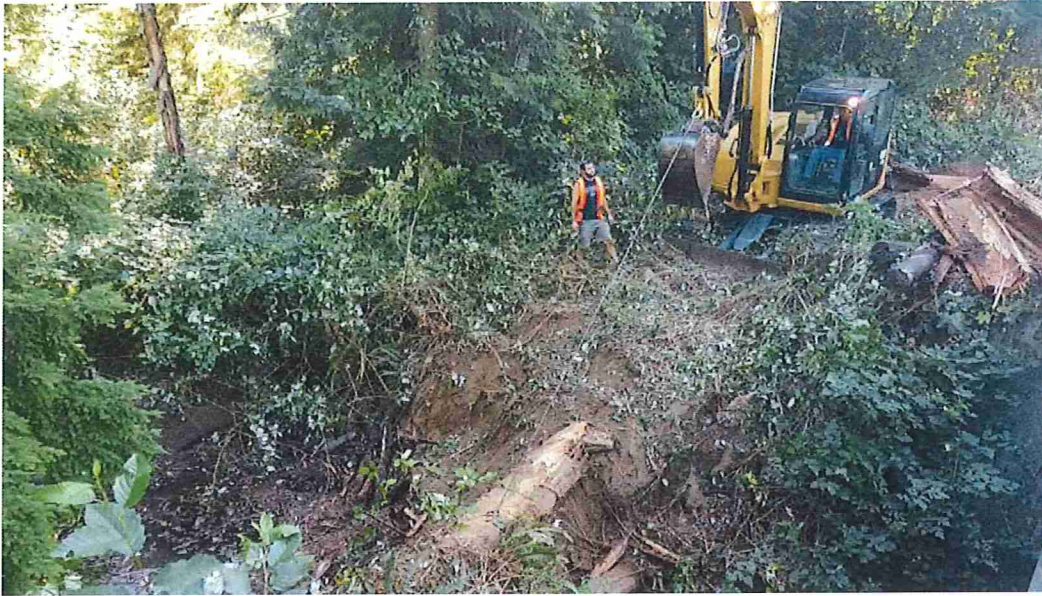
Photo 3: Systematic removal of old footbridge and excavator working from the top of bank.

Works were completed by Spence Excavation using a CAT 308E 2 CR excavator. The excavator was used to create an access road along the east bank of the watercourse and worked from above the top of the bank only. Debris was systematically removed, placed above the highwater mark and hauled offsite to be disposed of appropriately. A few pieces were left in the riparian zone as large woody debris.

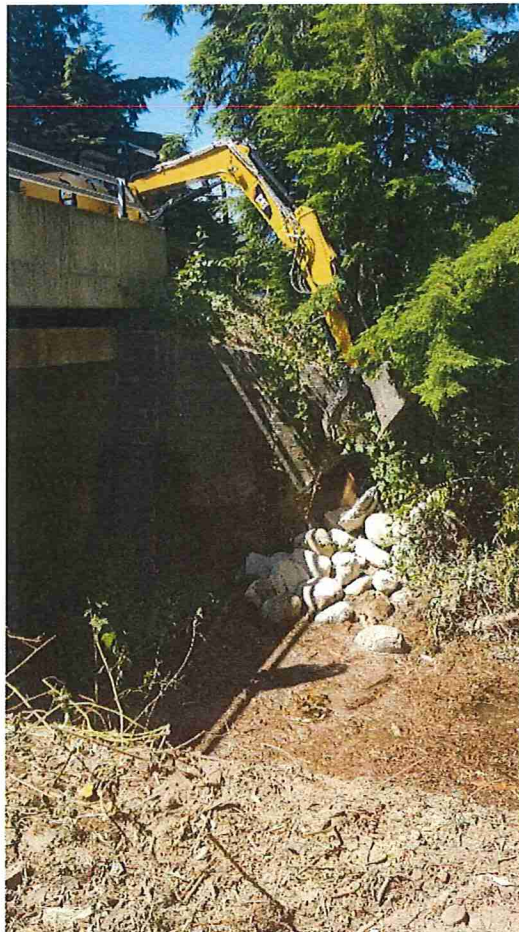
Photo 4: Placing of rock within the void created from the removal of the foot bridge.

The removal of the debris caused a void along the west bank of the watercourse, adjacent to the road crossing. This void was backfilled with rock that was placed from the bridge deck of the Senkler Road.

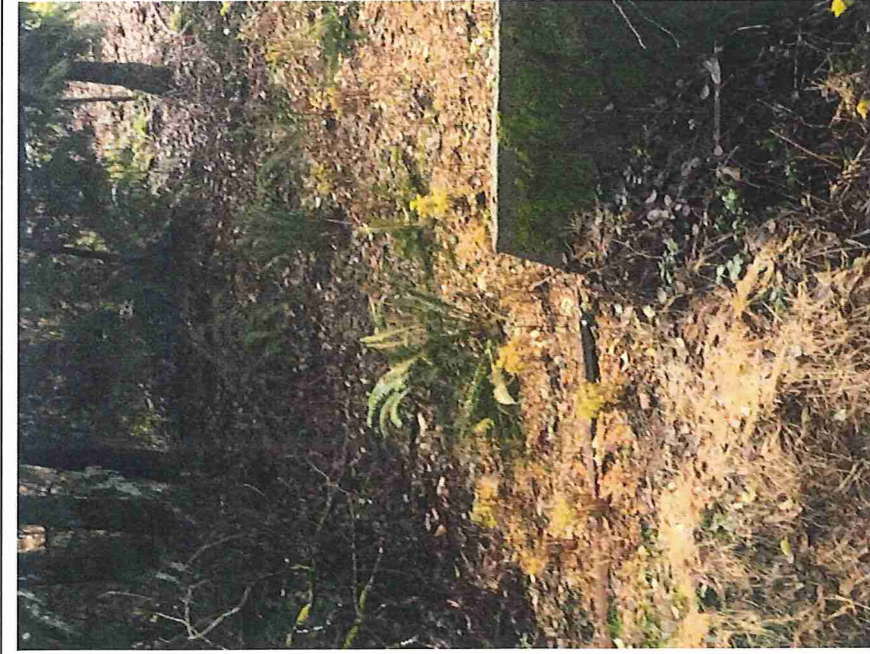
Photo 5: Viewing east along the final riparian planting.

Instream works were completed on August 7, 2018. Exposed soils along the east bank were covered in a thick layer of straw until riparian planting could be completed in the fall. Rehabilitation (replanting works) were completed November 14, 2018.

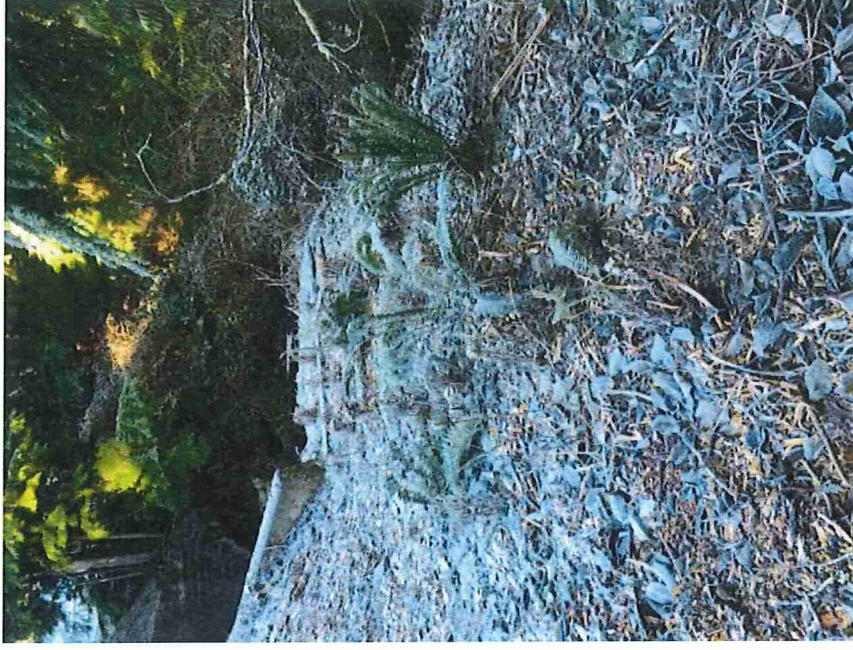
Photo 6: Viewing west along the final riparian planting.

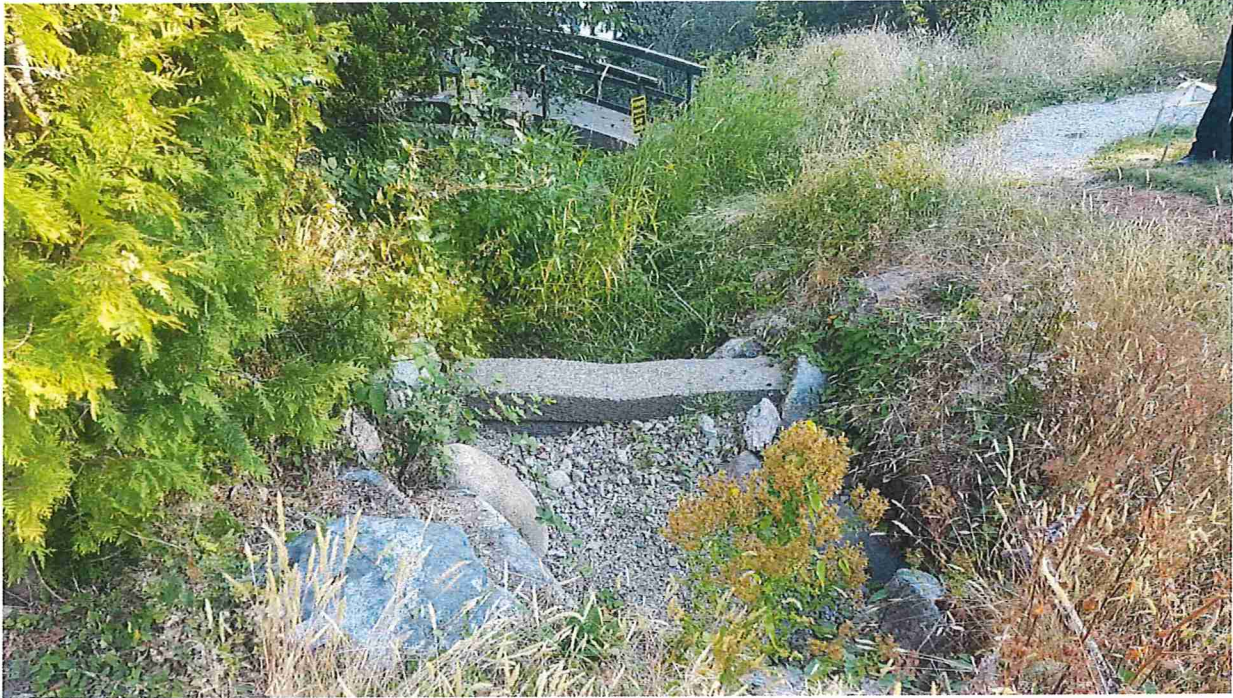
Photo 1: Site prior to works occurring.

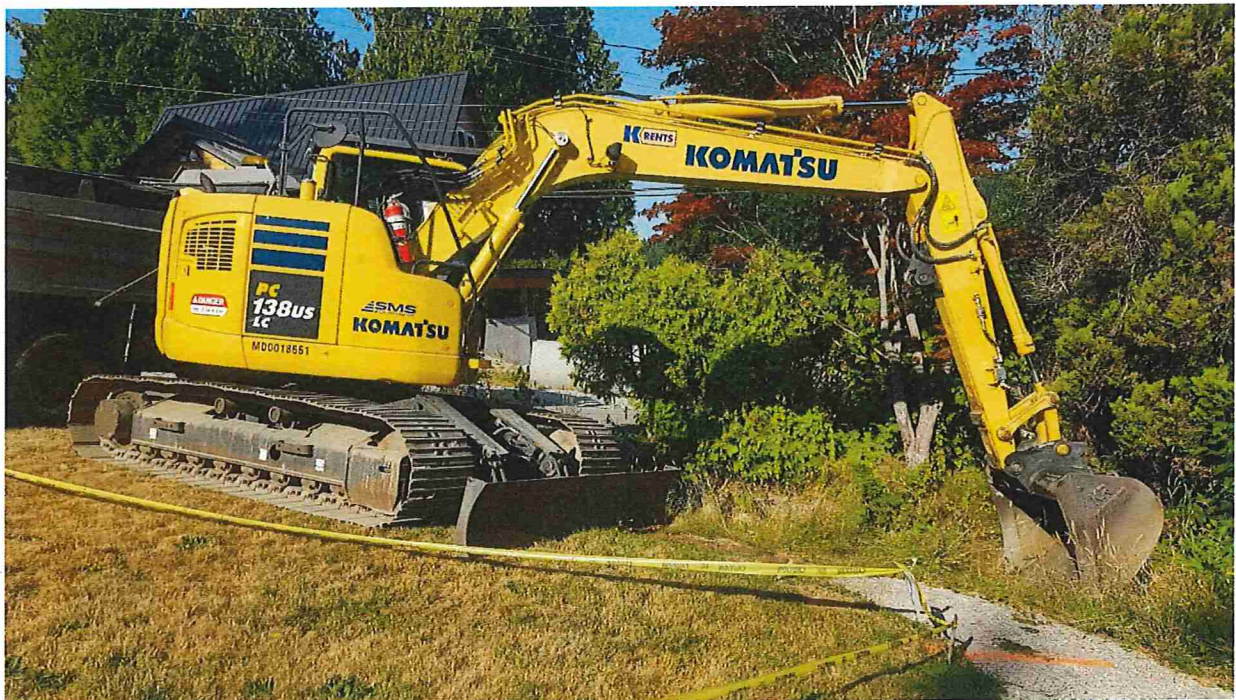
Photo 2: Excavator and haul trucks working from outside the top of the bank.

Works were completed by Sandpiper Contracting LLP using a KOMATSU PC 138 US LC excavator. The excavator worked from the top of the bank only and did not enter the watercourse. Excavation of the channel at the location of the culvert occurred and structural material was placed. All removed soils and debris were hauled off site and disposed of appropriately. The culvert was installed and then the crossing backfilled. Sandbag headwalls were constructed at the ends of the culvert.

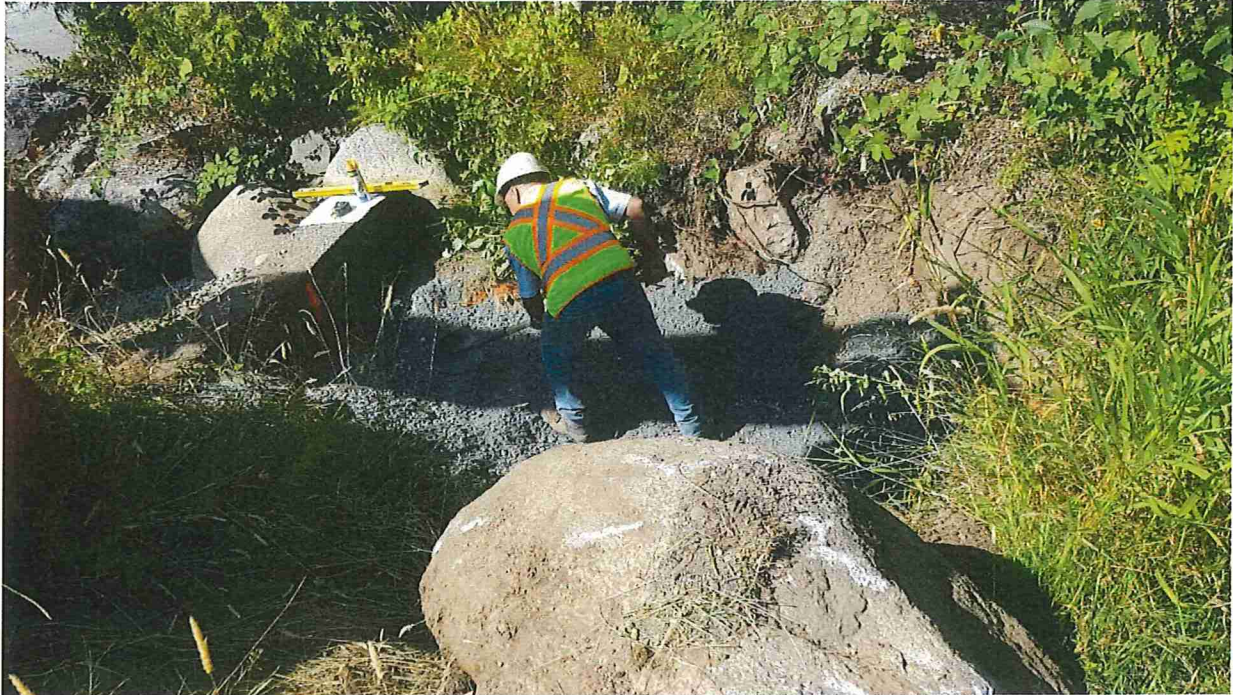
Photo 3: Placing of structural materials.

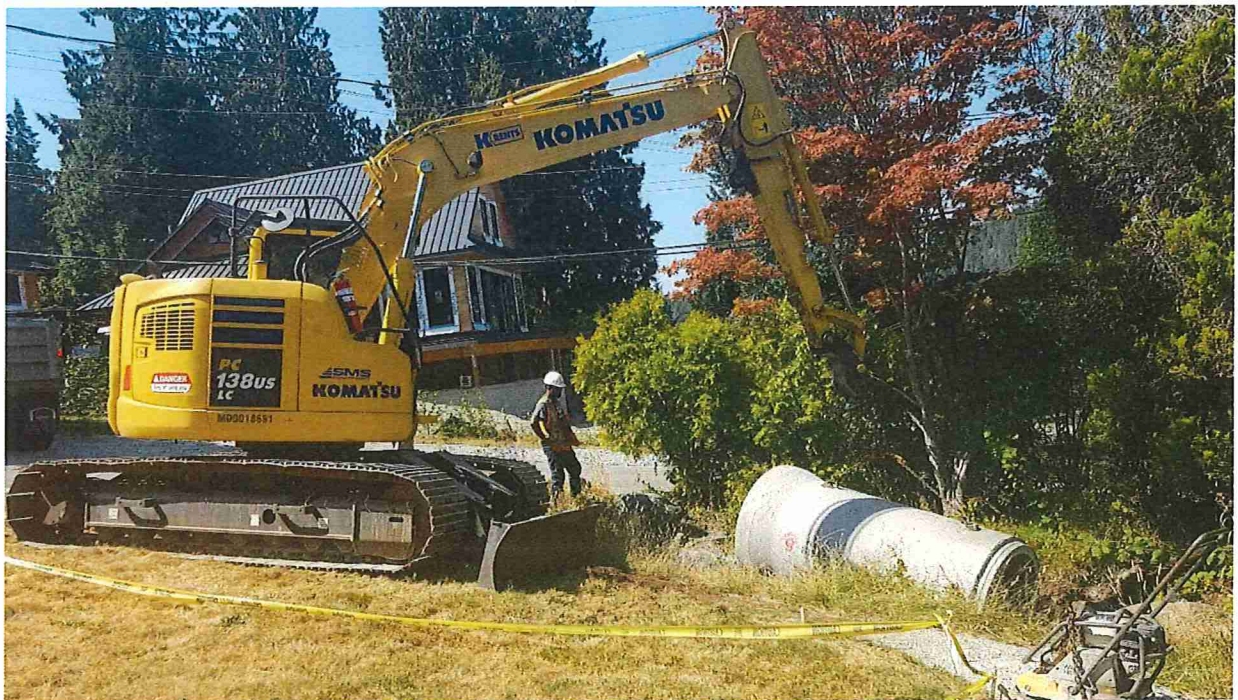
Photo 4: Installation of culvert.

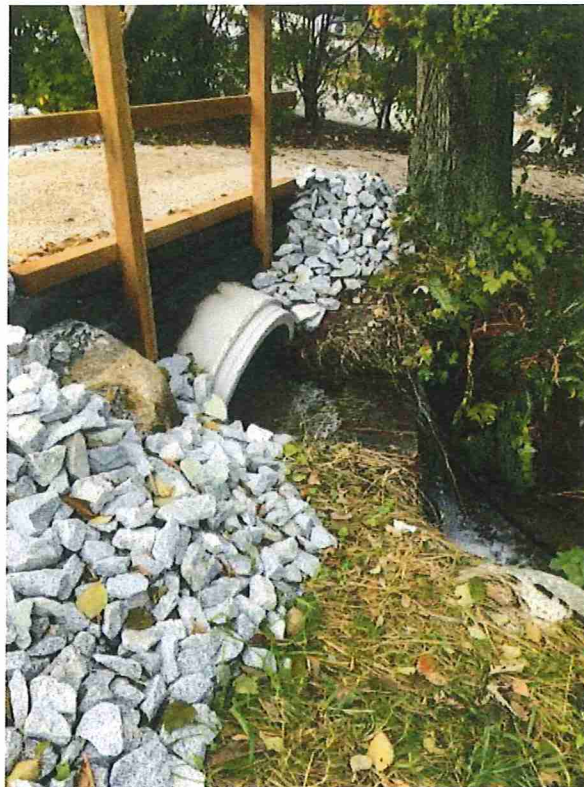
Photo 5: Completed stream crossing.

Please consider this our Final Report involving the construction of Tatlow Trail including the installation of a culvert within Avalon Creek in Belcarra BC. Letts Environmental Consultants Ltd. (Letts), were retained by the Village of Belcarra to monitor the works, which involved the installation of a 900mm diameter concrete culvert between two existing concrete weirs and armouring of the headwalls to allow for a public trail and stream crossing. Sandbags headwalls and a wooden fence was constructed along the stream crossing to ensure public safety.

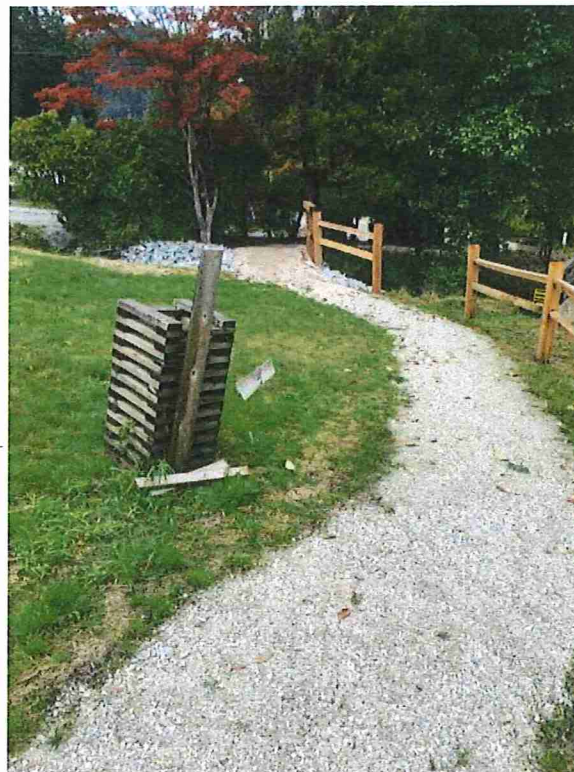
Photo 6: Final trail construction and viewing at the stream crossing.

Instream works were completed on August 9, 2018. Exposed soils along the east bank from excavator tracking were covered in a thick layer of straw until trail construction was completed. All works were completed by September 20, 2018.
