BEDWELL BAY WRECK — WESTERN DISPATCHER

Official Number: 190573

STATUS

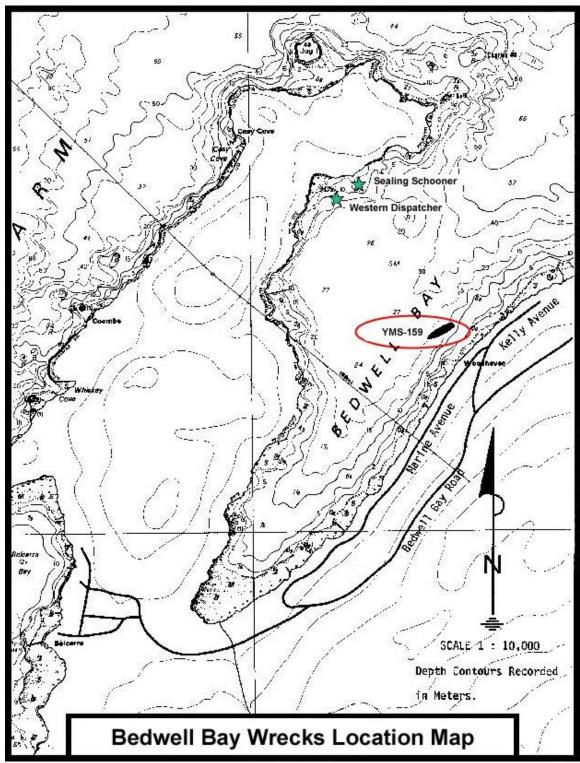
Then came the break-up. The hull split in two just ahead of the superstructure. The bow now lies on its starboard side. The foredeck is a jumble on the sand. Only the hull bottom and one or two timbers on the port side span the break. Many other timbers, pipes, and planks protrude haphazardly from the gap. Aft of the break, the wreck remains much as it was before. There is no additional damage and it is still at the same list. Even the remnants of the superstructure still stand — for now.

The ship did not actually roll. The forward topsides fell over. Divers found a tear in the hull which runs forward from the break along the port side. Above it, the sides have fallen to starboard. Below it, the hull remains attached to the rest of the ship. The break occurred at the main hold for good reason. That enormous cavern was inherently weak, probably exacerbated by the transition from steel frames under the engines to wooden ones forward.

Site notes and videotape record the *Western Dispatcher's* current condition and features. UASBC proposes periodic monitoring of the wreck until it is established that she has achieved equilibrium.
