ROAD CORRIDOR ASSESSMENT REPORT VILLAGE OF BELCARRA

November 1, 2017

4204.0002.01

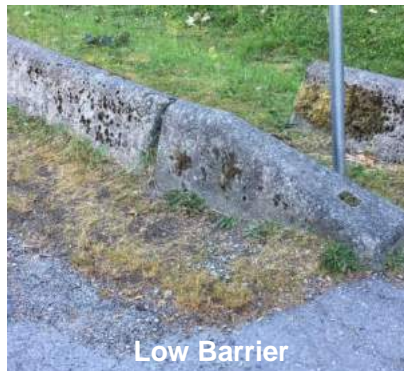
Low Barrier

During the field review, it was found that most of the Village's concrete road-side barriers are in fair to good condition with only mild corrosion, spalling and chipping. All of the W-beam road-side barriers are new in the past few years and they are in excellent condition.

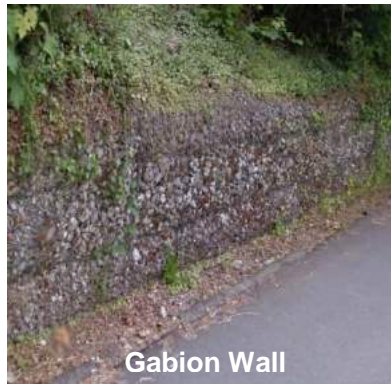
Gabion Wall

The only notable deficiencies found are on the two gabion retaining walls. The walls are at the intersection of Bedwell Bay Road and Main Avenue and the other retaining wall is at Bedwell Bay Road and Kelly Road. Both walls show signs of wire deterioration and bulging. Village staff have been maintaining the wall at Bedwell Bay Road and Main Avenue by adding wire and reseating the fill rock to keep it in place. The north-west lane of Bedwell Bay Road is built on top of the gabion wall at Bedwell Bay Road and Kelly Road and therefore this wall would have the highest impact if the wall was to further deteriorate or fail. It is our recommendation that both walls be assessed by a qualified Geotechnical Engineer to determine if there are any concern with these walls, provide recommended actions, timing and cost if any work should be considered in the next 5-10 years.

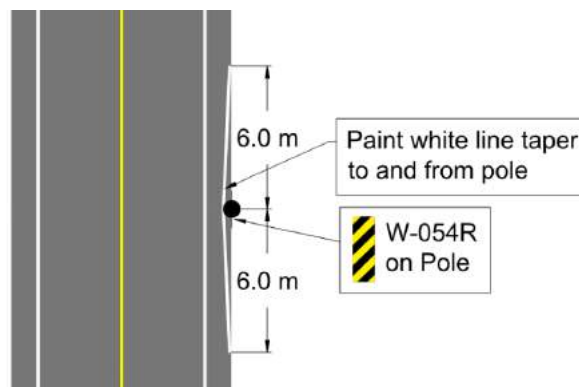
In the newly paved section of Bedwell Bay Road, the contractor paved around a power pole which creates a potential hazard for vehicles and cyclists. It is recommended that the pole be relocated off the road to ensure this hazard is eliminated.

Currently there is a reflective sign on the pole but until the pole is relocated, the Village may wish to add additional paint lines to guide motorists and cyclists around the pole. Below is a graphic showing a potential layout of the barrier at this pole. The Village may wish to add additional signage in advance of this hazard. To fully scope out a solution, the Village could draw upon the services of the Municipal Insurance Association of BC (MIABC) risk management team.

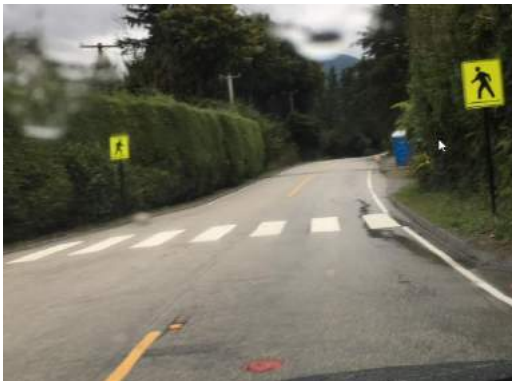
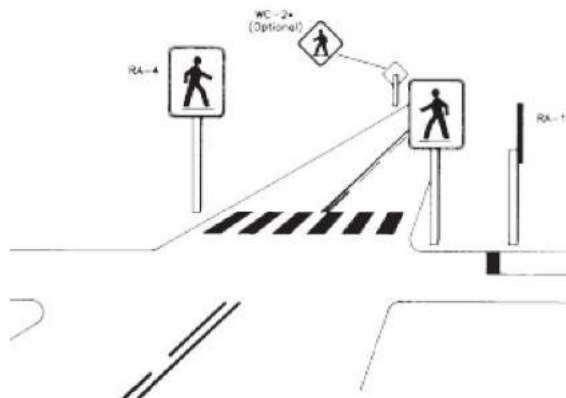
It was mentioned by Village staff that the current cross walk signage is yellow and not the standard white cross walk signage. In checking with the Ministry of Transportation and Infrastructure (MOTI) design guidelines for signage, it was confirmed that the standard cross walk signage is white and a yellow diamond shaped signage is typically used as an approach warning. Approach signage is optional but if installed should be mounted 65m before the cross walk given a 50km/h speed limit.

For the low cost of switching the signage to the white version, it is likely worth the cost and effort to reduce potential liability for the Village. To confirm the need to switch out the signage, the Village could draw upon the services of the Municipal Insurance Association of BC (MIABC) risk management team.
