VILLAGE OF BELCARRA

DRINKING WATER QUALITY ANNUAL REPORT

2016

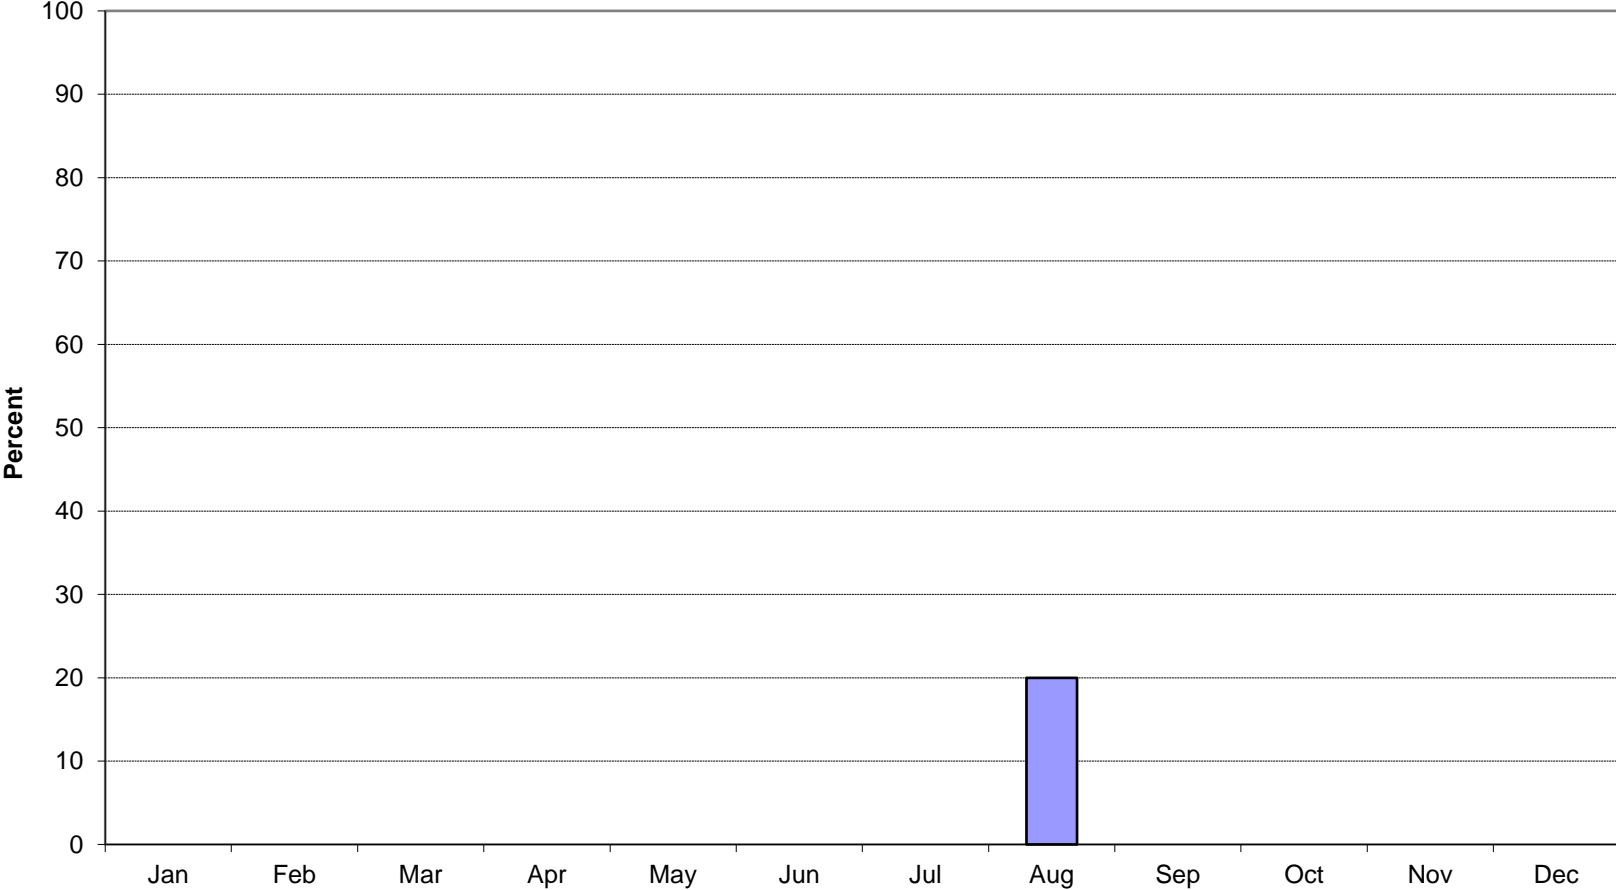
APPENDIX E
Metro Vancouver Results of HPC counts

VILLAGE OF BELCARRA - MONTHLY HPC COUNTS FOR 2016

■ Percent of samples per month containing greater than 500 CFU/mL of heterotrophic plate count (HPC) bacteria. High HPC levels are an indication of bacterial regrowth.

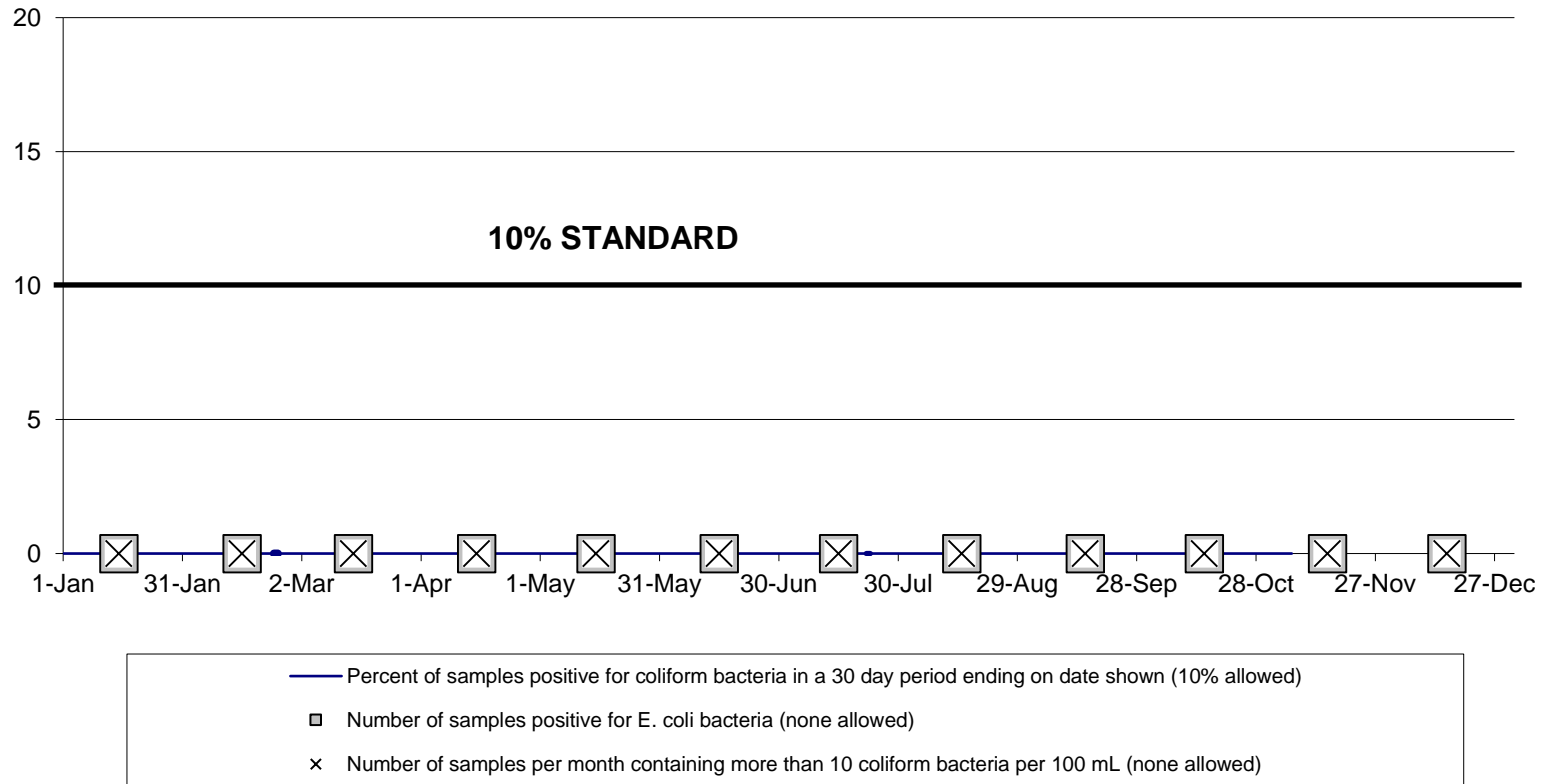
APPENDIX F

VILLAGE OF BELCARRA FOR 2016

Results of Bacteriological Analyses of Potable Water Samples Compliance With BC Drinking Water Protection Regulation
