# VILLAGE OF BELCARRA

## DRINKING WATER QUALITY ANNUAL REPORT

2018

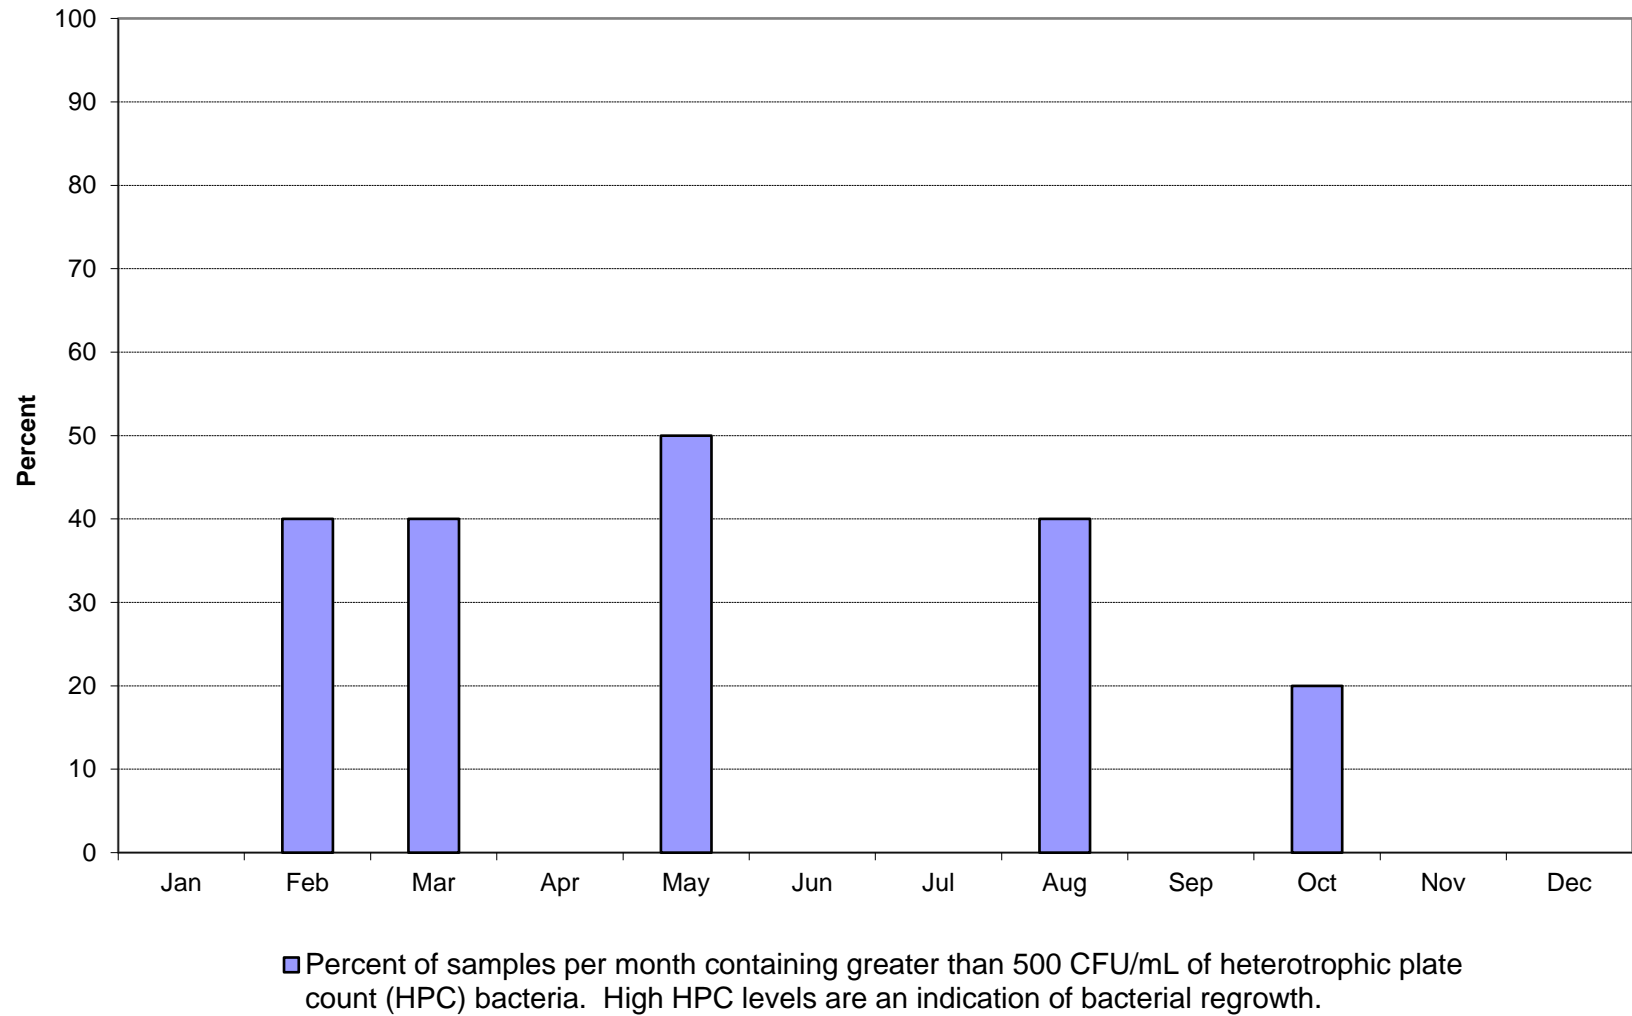
### Appendix E

#### Village Of Belcarra - Monthly Hpc Counts For 2018

**Nine** HPC samples were above and **ten** Chlorine sample were below the recommended guidelines. Public Works flushed those water mains until turbidity subsided and chlorine levels were elevated. Water main bleed rates at the water samplers were then increased on the deficient water main ends to reduce stagnation.

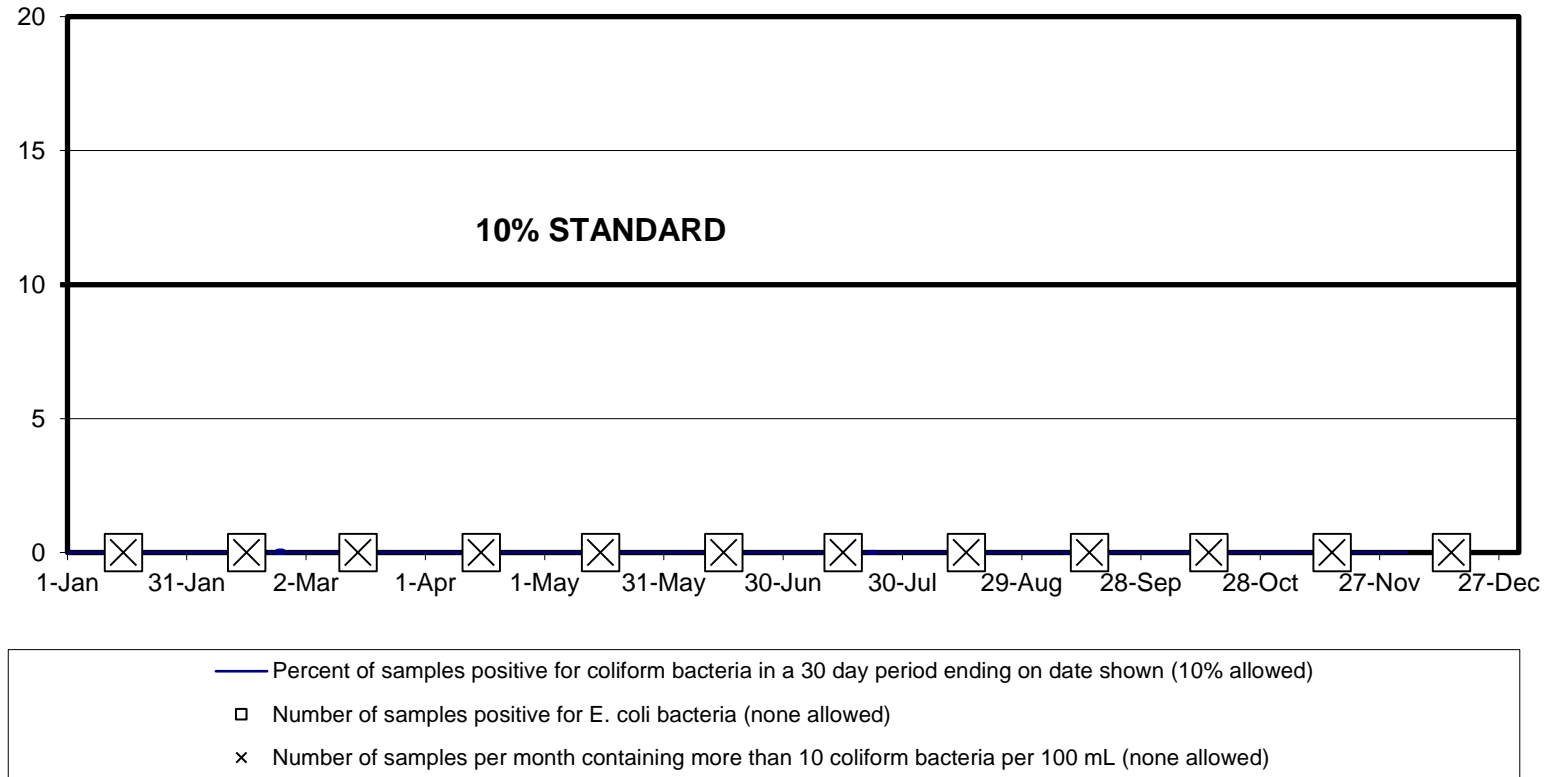
**Appendix F**  
**Village Of Belcarra - 2018**

**Results of Bacteriological Analyses of Potable Water Samples  
 Compliance With BC Drinking Water Protection Regulation**
