## **SASAMAT VOLUNTEER FIRE DEPARTMENT (SVFD) BOARD OF TRUSTEES MEETING**

##### **3.1 SVFD Fire Hall Replacement – Village of Anmore and Village of Belcarra**

issued: 2019-04-18

# anmore and belcarra firehalls condition and needs assessment

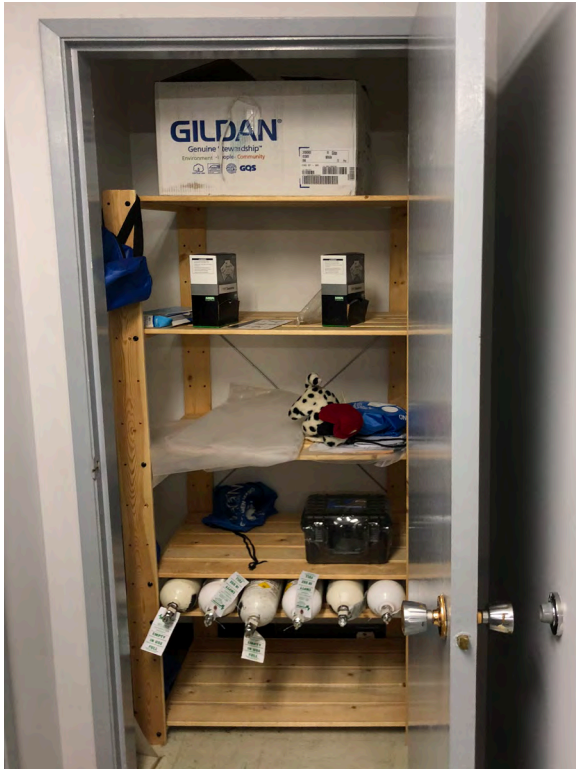
Storage area for SCBA equipment - this is located on the clean side of the hall

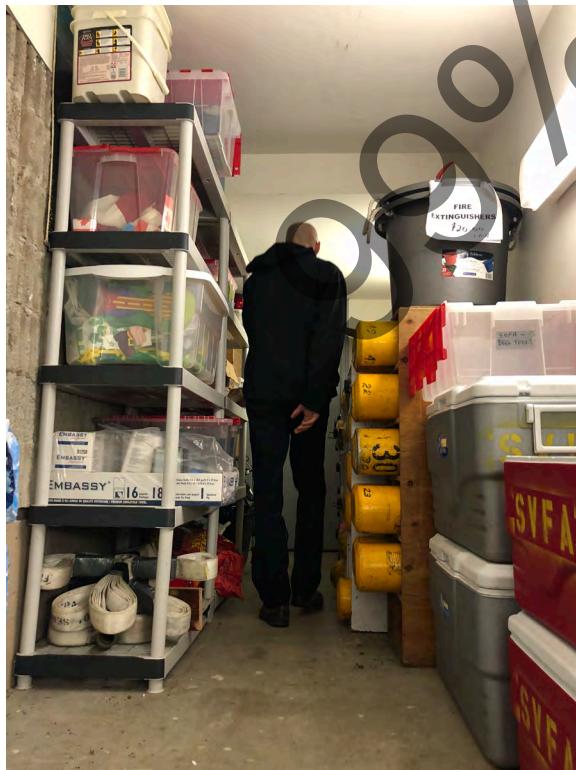
Storage of firefighting equipment narrow and difficult to utilize efficiently.

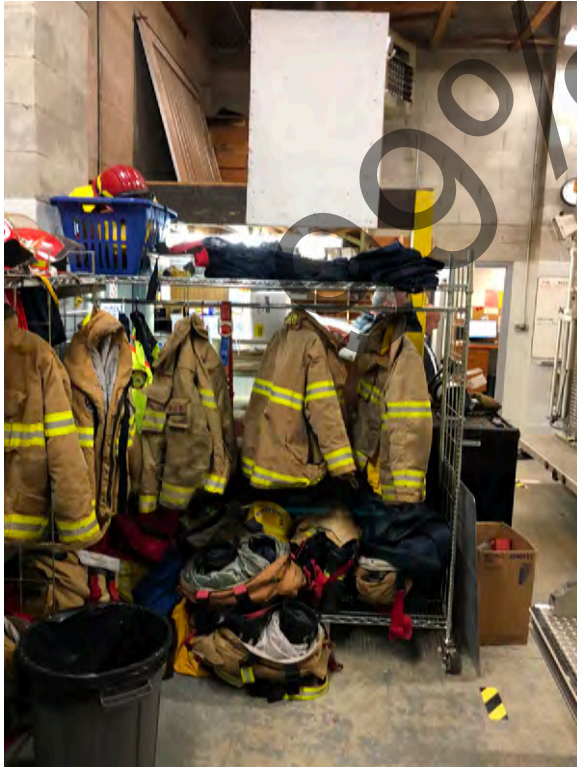
PPE hanging area is small for department size, also set to dry in apparatus bays and exposed to vehicle contaminants.

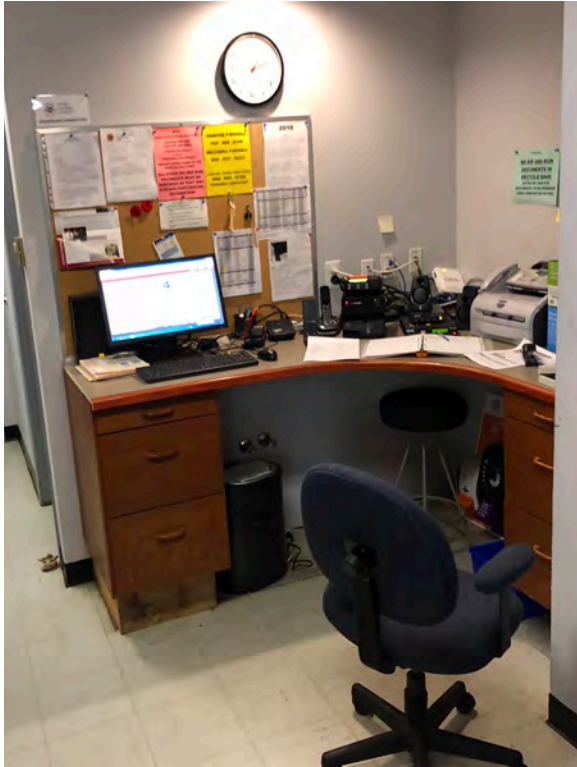
Limited office space adjacent to the apparatus bays - clean side.

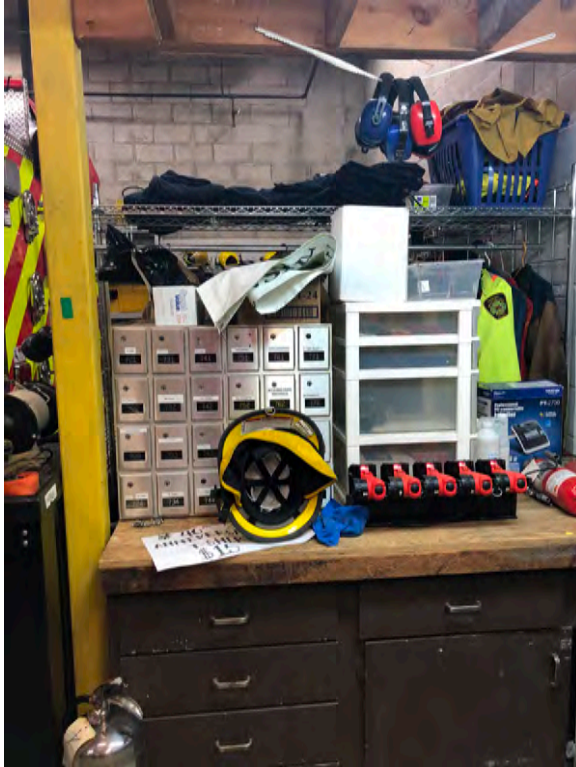
Workspace and storage limited.

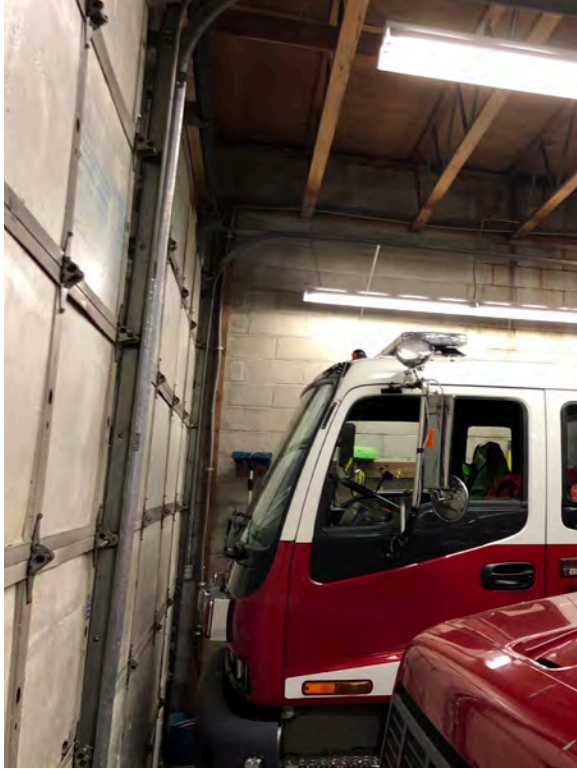
Extremely narrow space between truck and apparatus doors - limiting crew flow to gear & vehicles.
